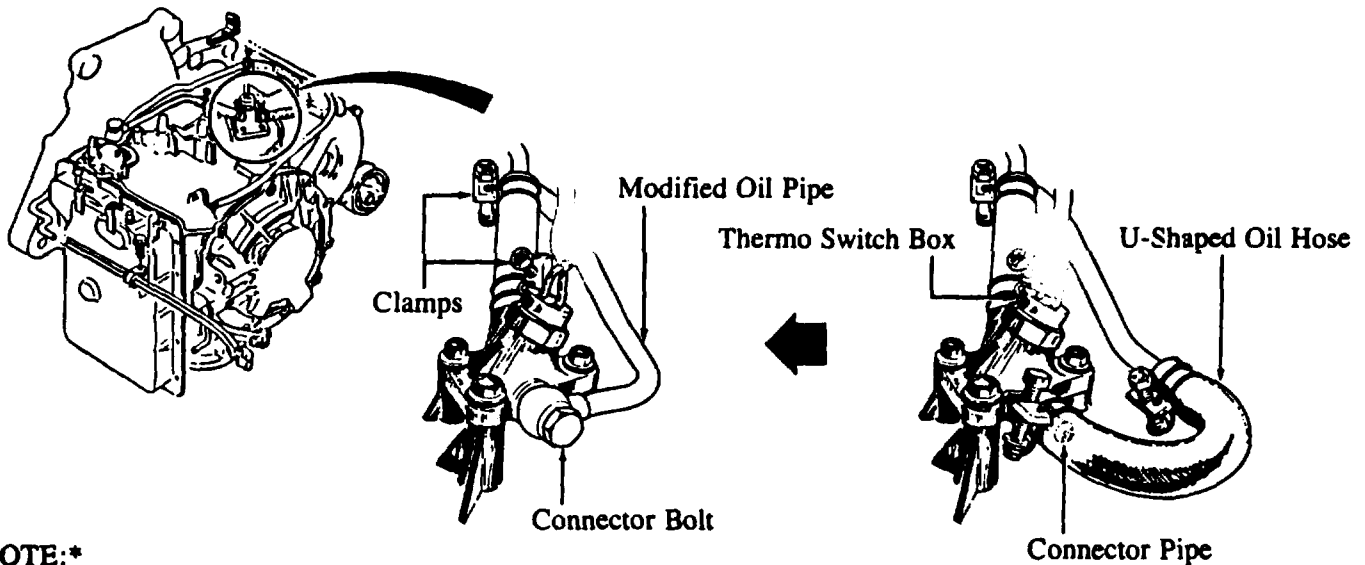
C. If the fluid level is low, check for leakage, especially near the thermo-switch box. Make sure the modified oil pipe is installed on 1988 models. If leakage is found, refer to the illustration below for repair procedures.

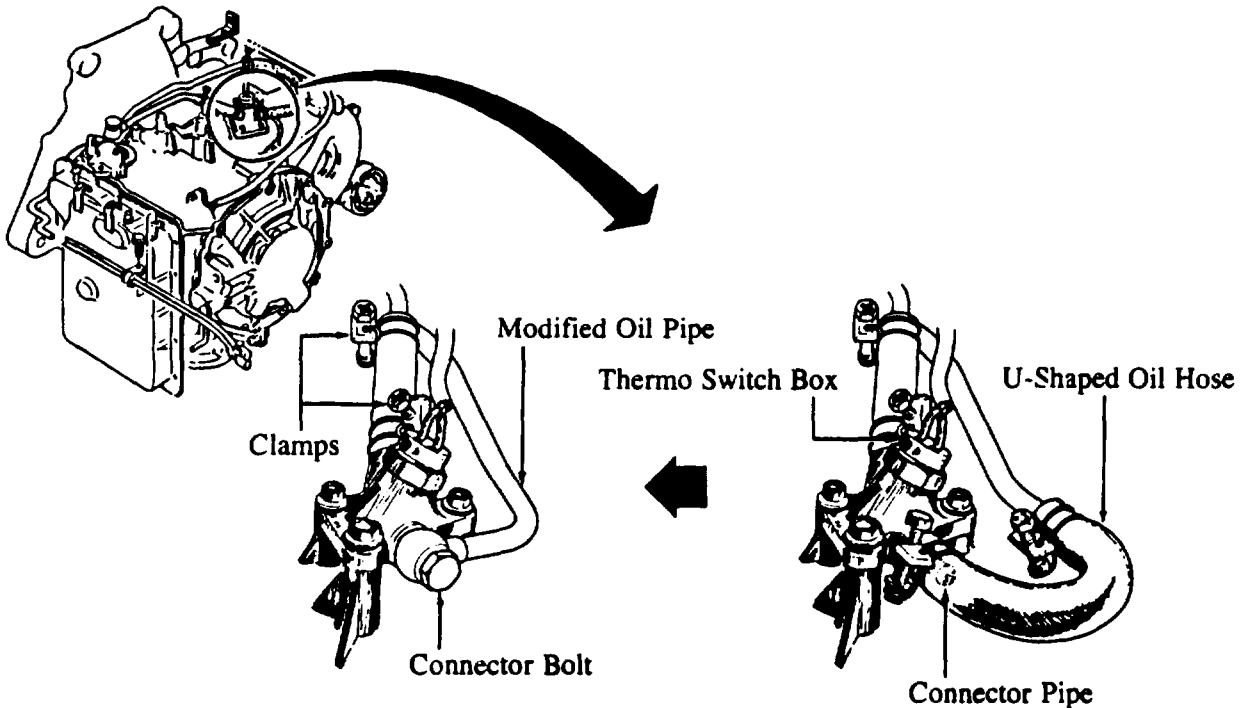
C. If the fluid level is low, check for leakage, especially near the thermo-switch box. Make sure the modified oil pipe is installed on 1988 models. If leakage is found, refer to the illustration below for repair procedures.

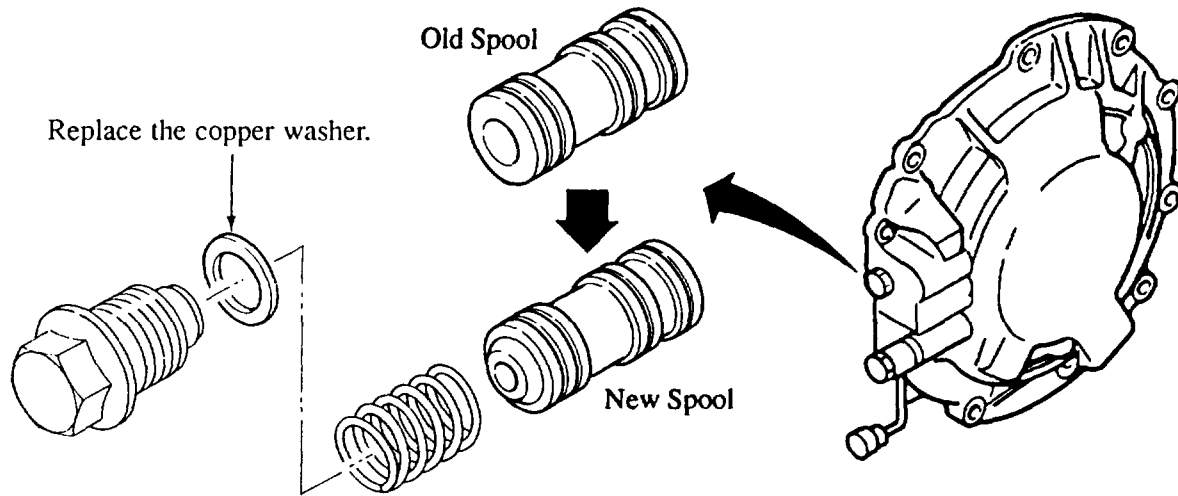
4. If a problem is found in Step 3, replace the oil pump spool valve according to the Replacement Procedure.
5. Recheck the line pressure according to Step 2 and perform the road test to confirm that the problem is fixed.

1. Lift up the vehicle on a hoist.
2. Remove the spool valve plug using 19mm swivel socket and a 6in extension.

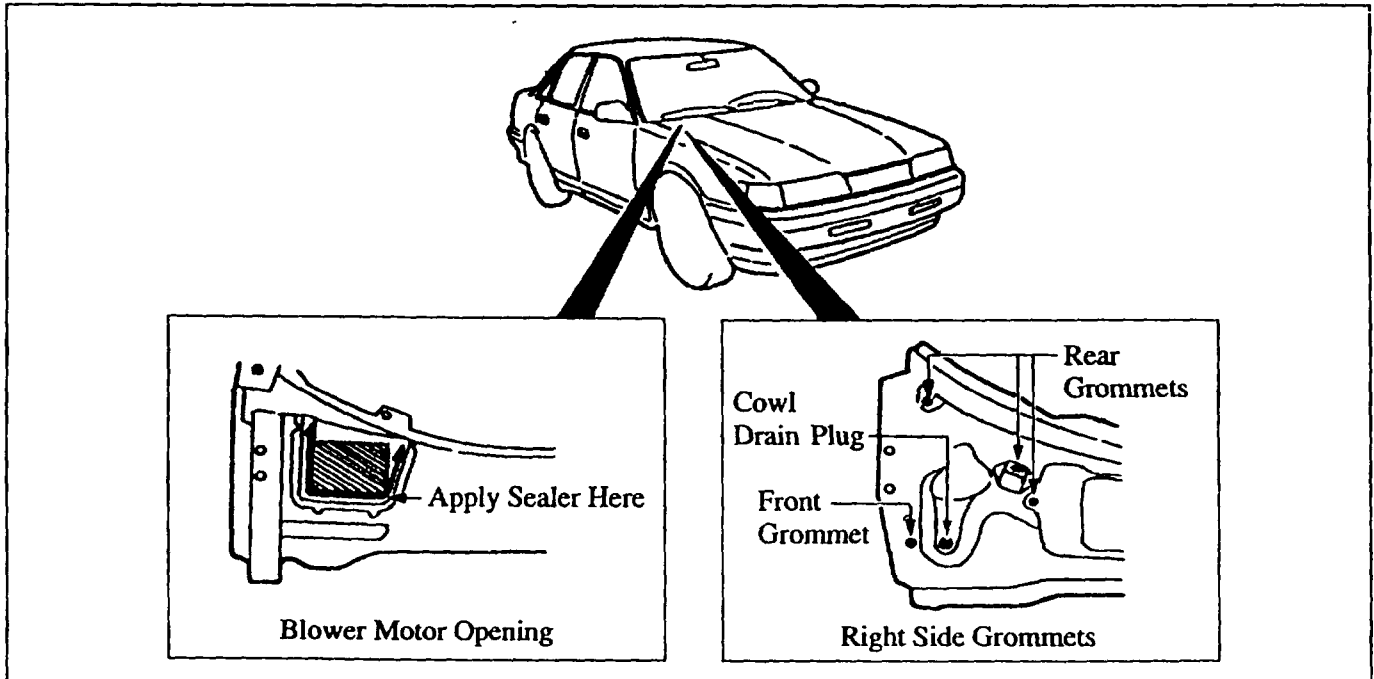
Figure 8: Checking Right Side Cowl for Leaks

5. If the grommets do not leak, seal the baffle seam by reaching up through the blower motor opening and seal the areas indicated in Figure 8.
6. If water is leaking from the the firewall, check for studs and grommets that might be loose or improperly seated on the engine side of the firewall. If necessary, remove, redress, and reinstall the studs. Retap the holes and, if necessary, replace the bolts. Apply sealer to the threads before installing the bolts. Apply silicone sealer to the bottom of the grommets prior to installation.

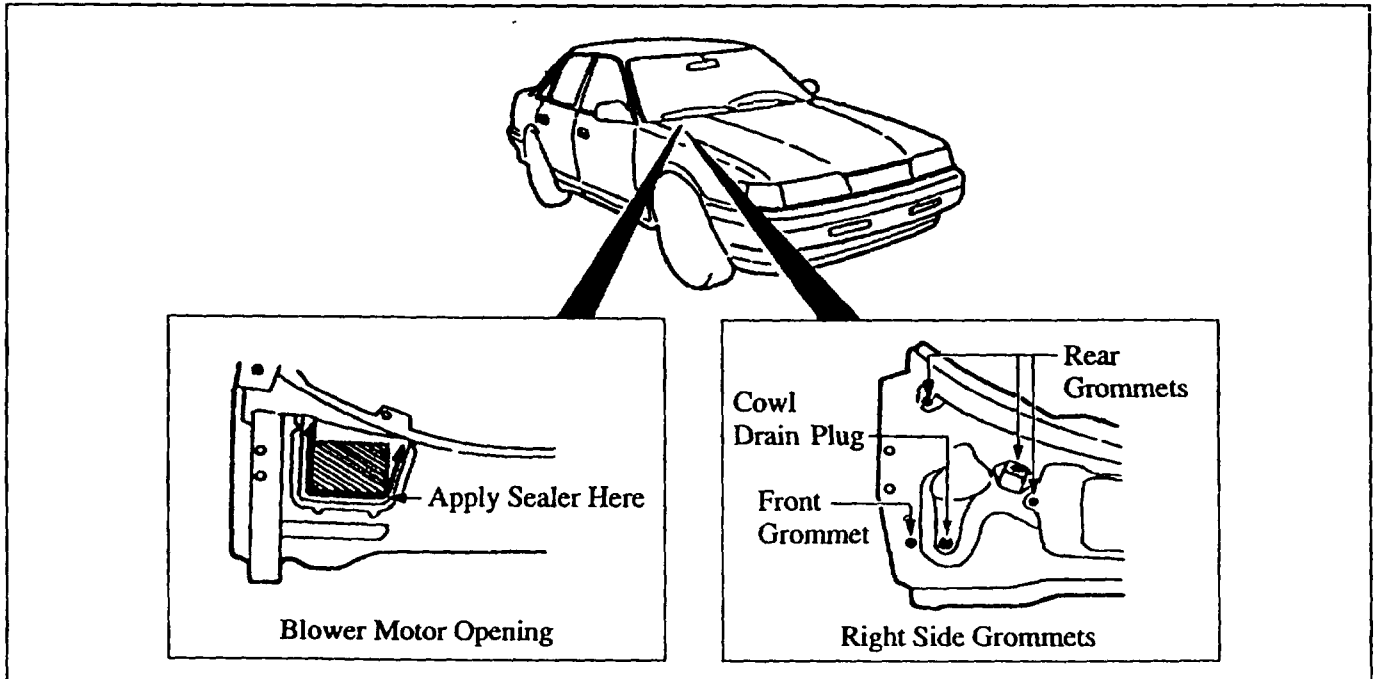
Figure 8: Checking Right Side Cowl for Leaks

5. If the grommets do not leak, seal the baffle seam by reaching up through the blower motor opening and seal the areas indicated in Figure 8.
6. If water is leaking from the the firewall, check for studs and grommets that might be loose or improperly seated on the engine side of the firewall. If necessary, remove, redress, and reinstall the studs. Retap the holes and, if necessary, replace the bolts. Apply sealer to the threads before installing the bolts. Apply silicone sealer to the bottom of the grommets prior to installation.
