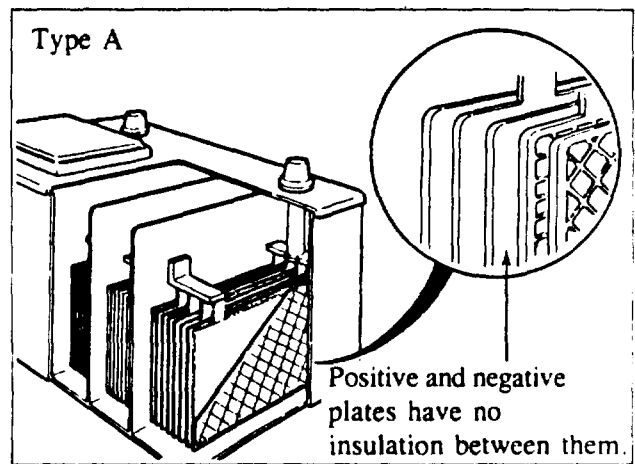
Early battery construction (Type A) provided no safeguard in regards to batteries shorting out from one cell to another.

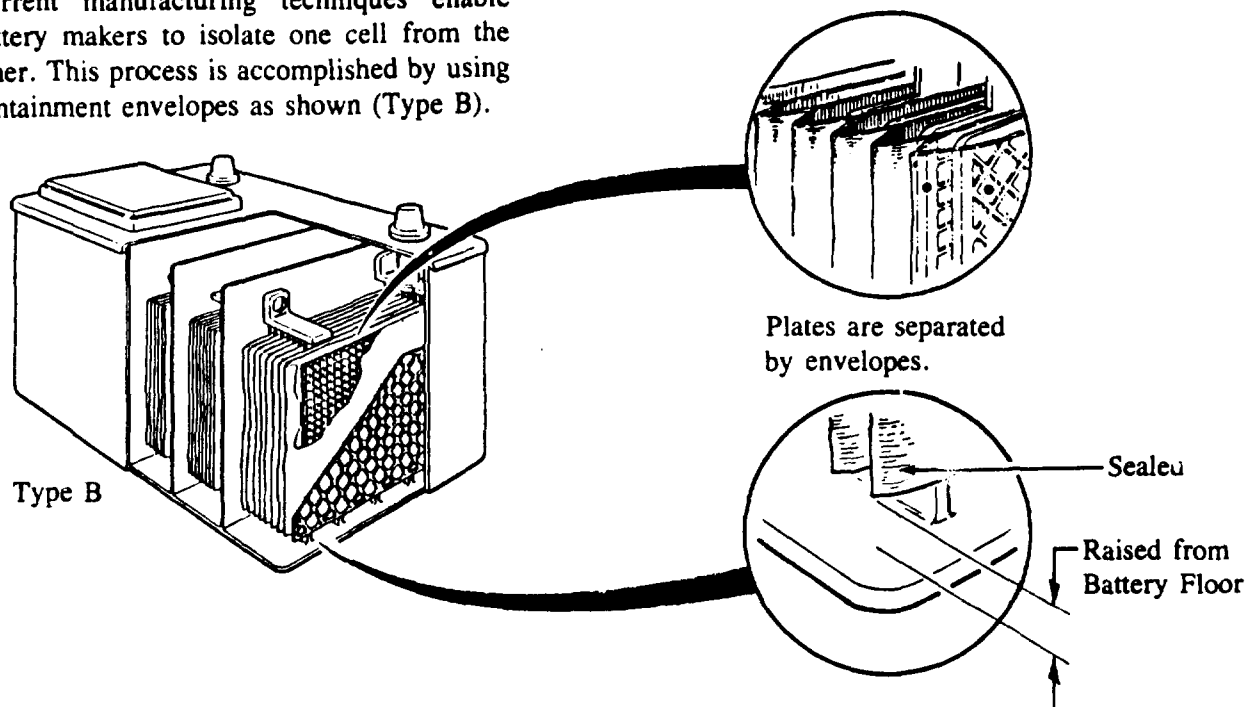
Current manufacturing techniques enable battery makers to isolate one cell from the other. This process is accomplished by using containment envelopes as shown (Type B).

1. Inspect the battery terminals and cable ends for white crystal deposits. Clean if necessary.
2. Inspect vent surface for acid deposits. If deposits are found, clean the surface. If excessive amounts are found and cannot be properly removed, replace the battery.

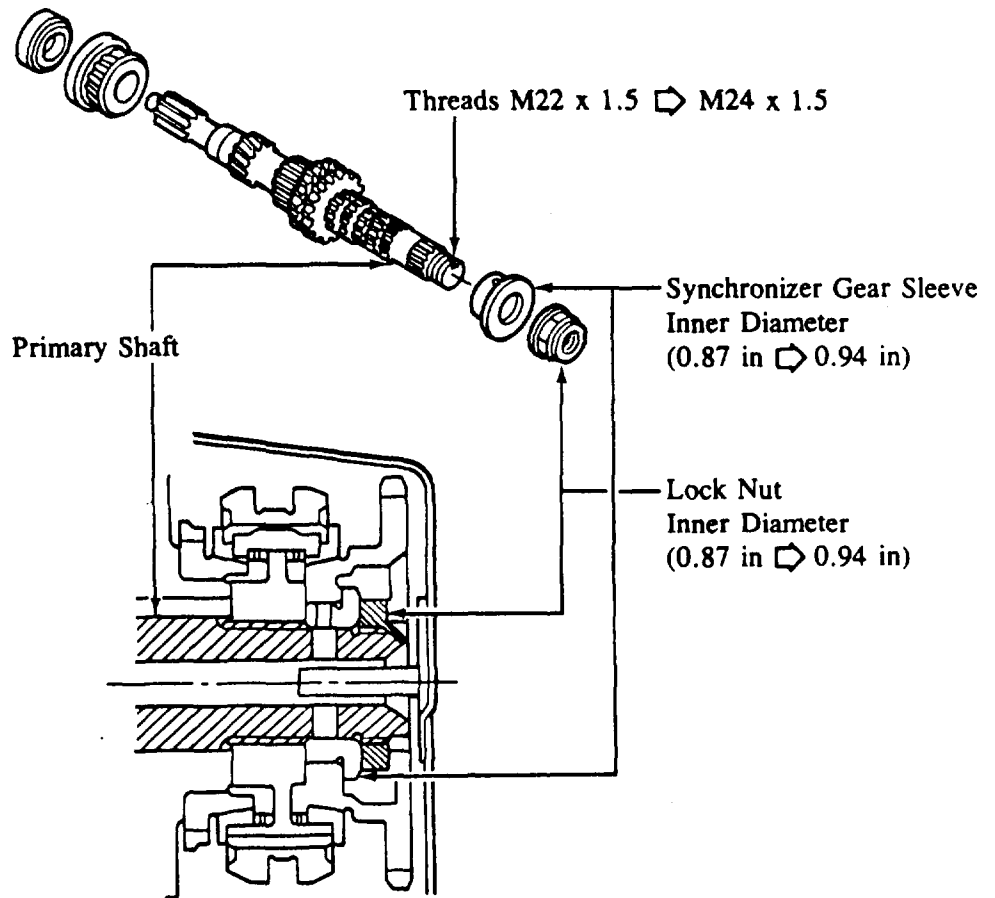
A diameter of the primary shaft end portion has been increased to 0.94 in (24 mm) from 0.87 in (22 mm) as shown below in order to increase the strength of the threaded portion of the primary shaft.

Due to the modification, the synchronizer gear sleeve and lock nut shown in the illustration have also been modified accordingly. Therefore, the modified primary shaft must be installed together with the modified synchronizer gear sleeve and lock nut.

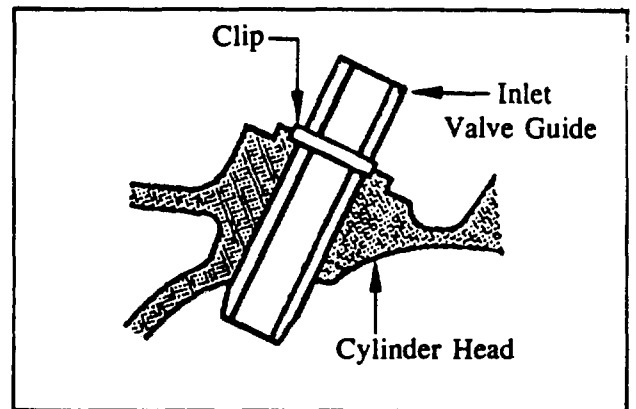
1. Spark plugs are fouled with oil and fuel.
2. Oil level is low.

A modification has been introduced in production since March 1989. In connection with that modification, clips have been installed on the inlet valve guides.

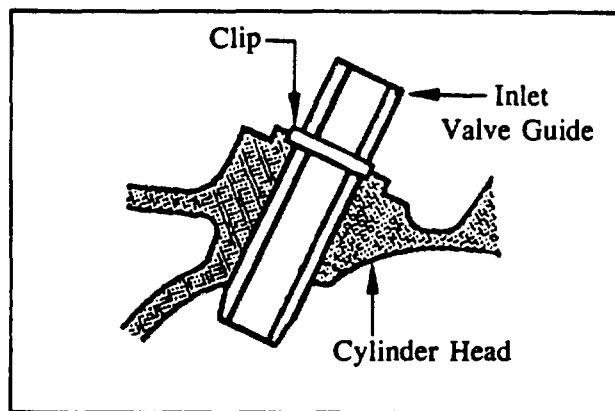
1. Spark plugs are fouled with oil and fuel.
2. Oil level is low.

A modification has been introduced in production since March 1989. In connection with that modification, clips have been installed on the inlet valve guides.

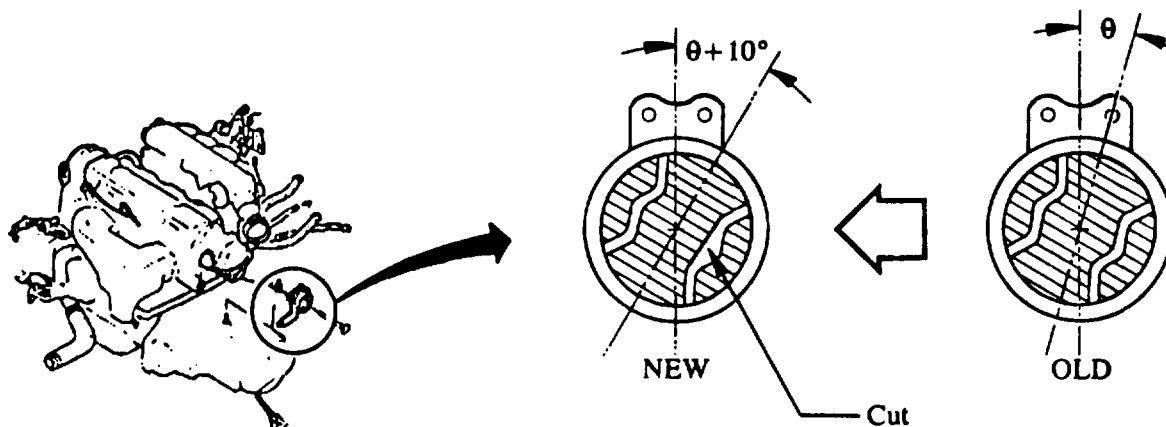
■ No. 1 Engine Mount

- The diameter of the rubber has been increased from 3.15 in. to 3.54 in. since the November 1988 production.
- The rubber has been turned 10° toward the engine side since the November 1988 production.

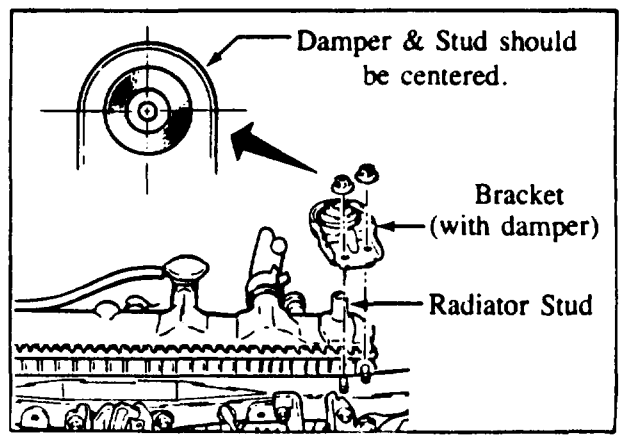
3. Check that the radiator is centered in the radiator upper brackets so that it can move more effectively as a dynamic damper. If not, adjust the radiator or the brackets as follows:

- Adjust the position of the upper brackets.
- Adjust the position of the radiator upper hose so that the radiator is not pushed or pulled out of position.

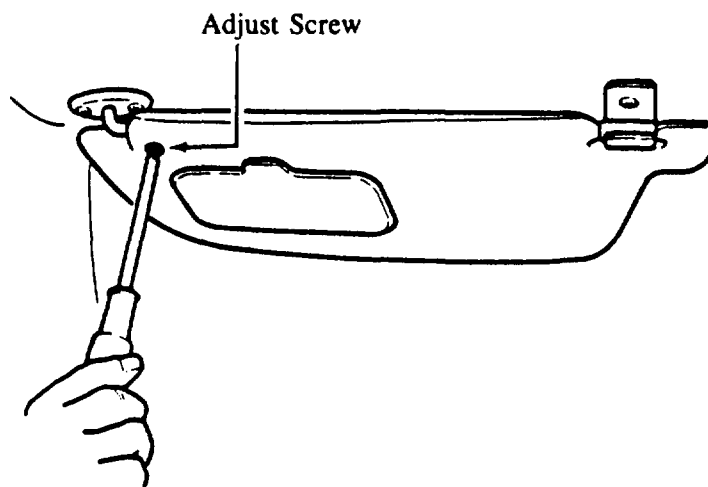
On 1988-89 323, 626/MX-6, or B2200/2600 models you may notice problems during PDI or encounter customer complaints regarding sunvisor operation (i.e. sunvisor will not adjust up or down, or will not remain at a set position).

Check the adjustment screw (as shown) prior to replacement. Adjust the screw to enable the driver and/or passenger to rotate the sunvisors to any set position.

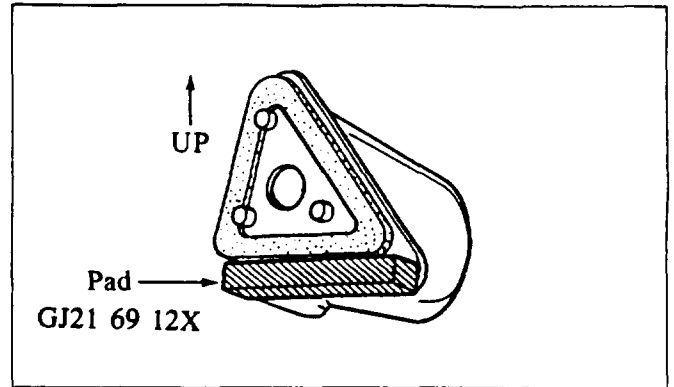
LOCATION 1 (DOOR MIRRORS)

Condition A: Wind Noise at Front Door Area During High Speed Driving

1. Using a flat screwdriver, carefully pry the inner sail garnish out of its position. (Start prying at top corner of sail garnish, then work downward).

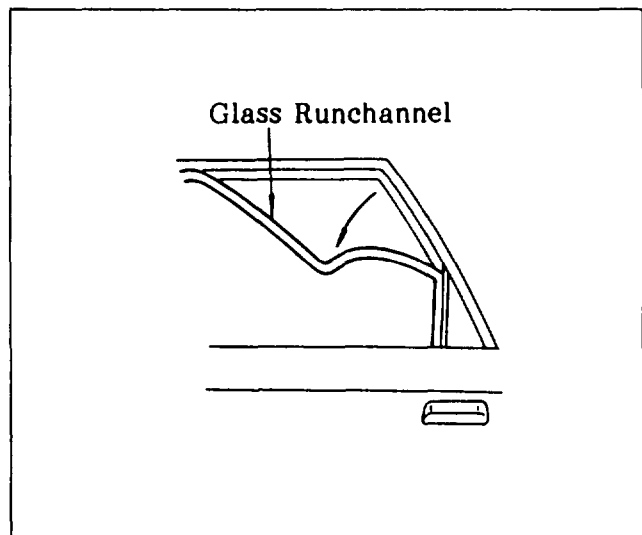
Condition B: Wind Noise at Rear Door Corner Area

1. Lower window all the way.
2. Pull off the rear corner section of the glass run channel.

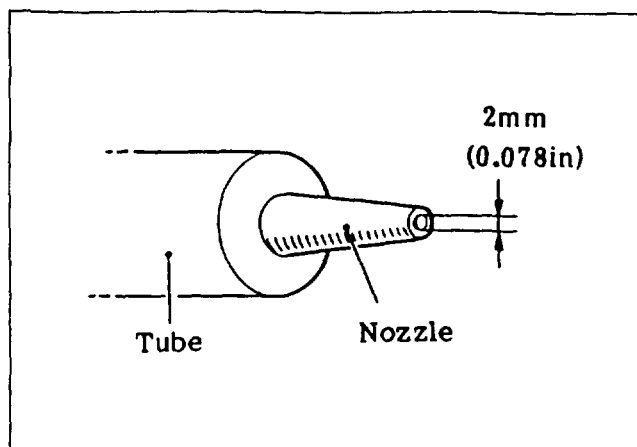
Condition C: Wind Noise/Fluttering Noise at Rear Quarter Window Area

1. Prepare a tube of silicone sealer as shown in the illustration.

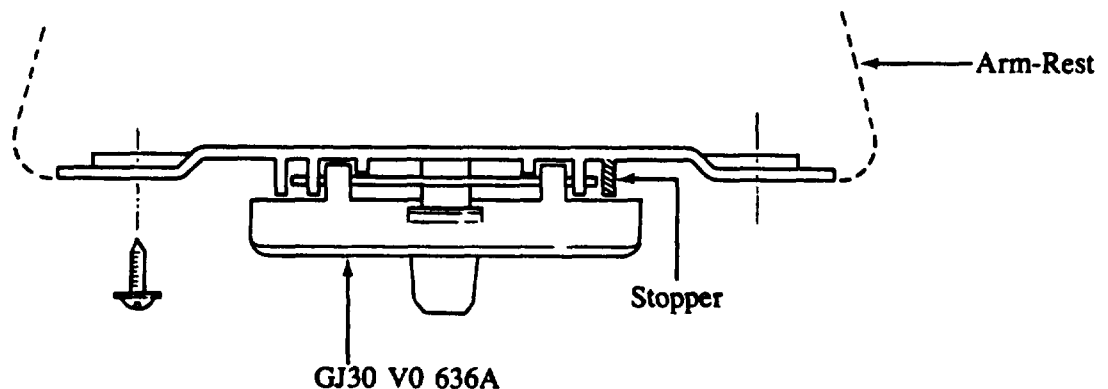
On some of the 1988-1989 626/MX-6 models on which the console lid had been replaced with an accessory arm-rest, the hinge pin of the console lid lock may be loose and create a rattling noise because no stopper had been attached to the accessory arm-rest.

If you encounter this problem, replace the lock plate in the accessory arm-rest with a modified one.

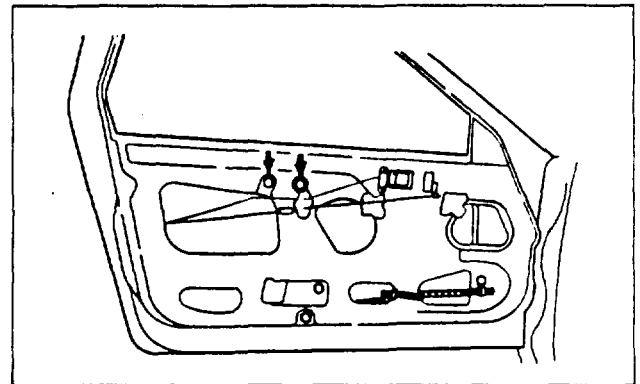
High friction of the ball movement inside the hose causes the hose and balls to get out of position, resulting in improper operation of the power window regulator.

Replace the power window regulator guide assembly, the motor bracket and the sprocket with the new one and change the hose routing according to the following instructions.

1. Remove the power window regulator from the door.
2. Disconnect the power window motor from the removed regulator.

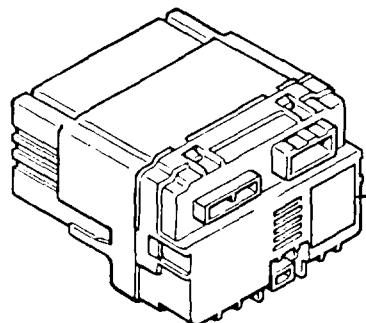
The soldering of C.P.U. terminal may crack and this will cause electrical malfunction of C.P.U. In this case, replace the C.P.U. with the modified one as shown. The modified C.P.U. has been installed in the production vehicles since November 1, 1988.

Although the part number of the C.P.U. has not been changed, the modified C.P.U. can be distinguished by a lot number on the C.P.U. as shown below.

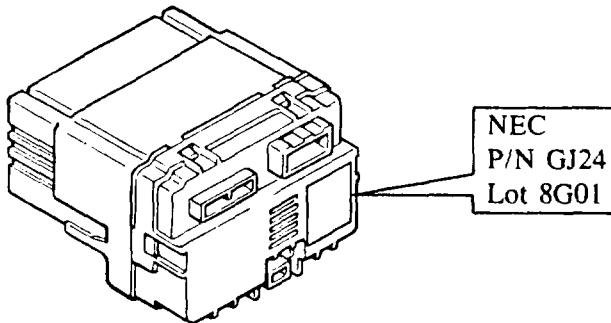
The soldering of C.P.U. terminal may crack and this will cause electrical malfunction of C.P.U. In this case, replace the C.P.U. with the modified one as shown. The modified C.P.U. has been installed in the production vehicles since November 1, 1988.

Although the part number of the C.P.U. has not been changed, the modified C.P.U. can be distinguished by a lot number on the C.P.U. as shown below.

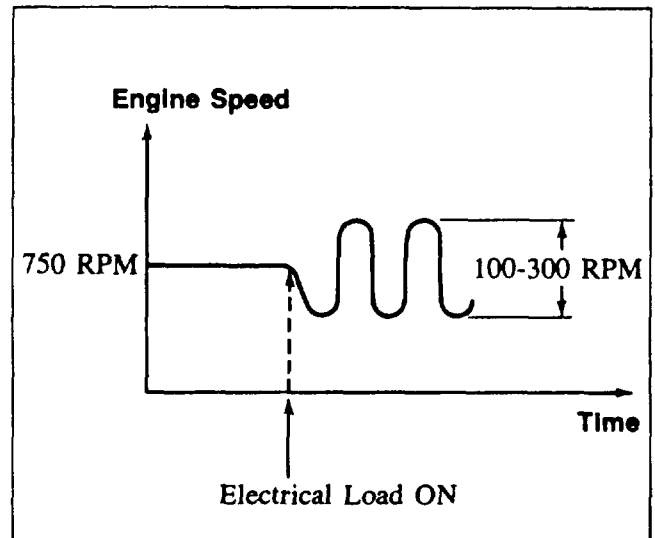
Idle speed fluctuation or hunting may occur when the electrical load such as headlights, rear defroster and so on are turned on while idling. This condition likely occurs easily if the idle speed is adjusted too low.

2. With the test connector NOT grounded, check for a fluctuation in the idle when the head lights and rear defroster are turned "ON". If fluctuation is present, ground the test connector and adjust the idle speed to 950 - 1000 RPM (in neutral with the parking brake applied).*

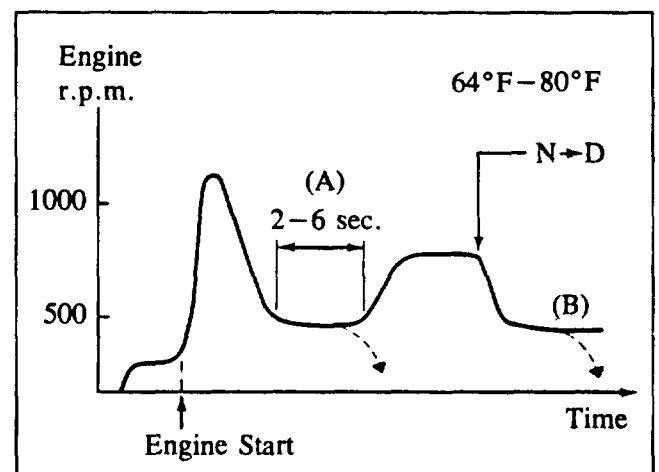
If the following conditions occur within 15 seconds after a cold start on a 1988-89 626/MX-6, install a repair kit according to the procedures shown in this bulletin.

The repair kit cuts the negative pressure applied to the pressure regulator for 15 seconds after starting the engine to compensate the air/fuel ratio.

This repair kit only functions for 15 seconds after the engine is started.

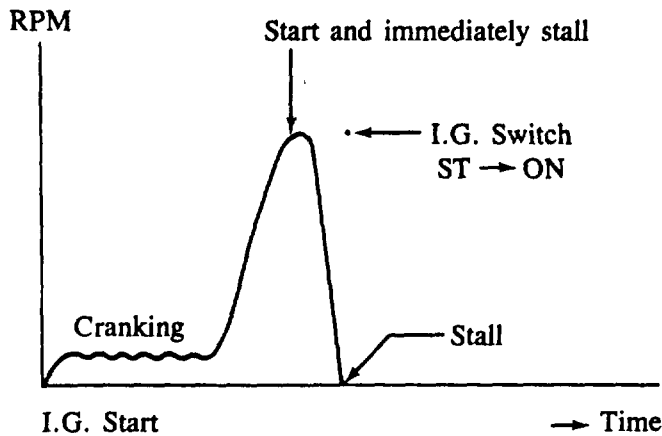
Problem Phenomenon

The problem is that the engine starts while the I.G. key is turned to the "START" position, but immediately stalls when the key is returned to the "ON" position. This occurs only when the temperature of the Emission Control Unit (E.C.U.) is approximately 0°C or less. However, the engine operates normally when the temperature is higher than 0°C.

1. Verify whether the engine stalls under the above condition.
2. Replace the E.C.U. if the problem is observed.

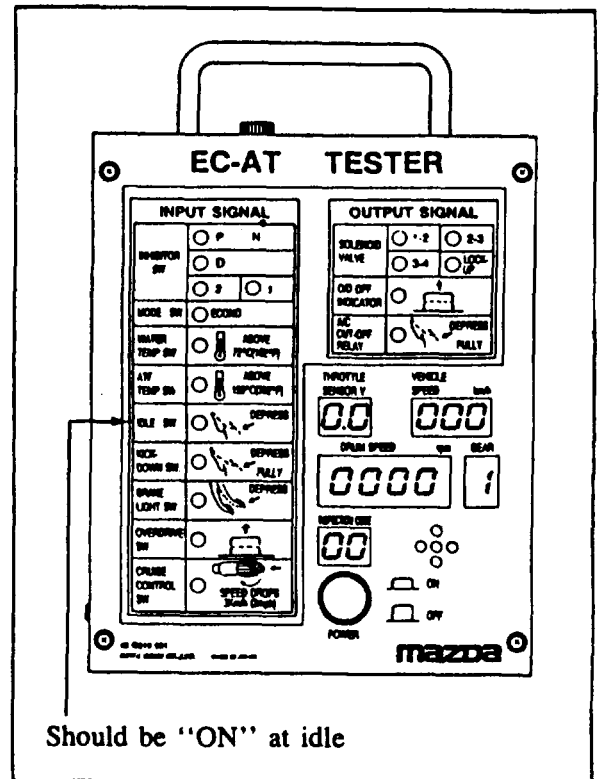
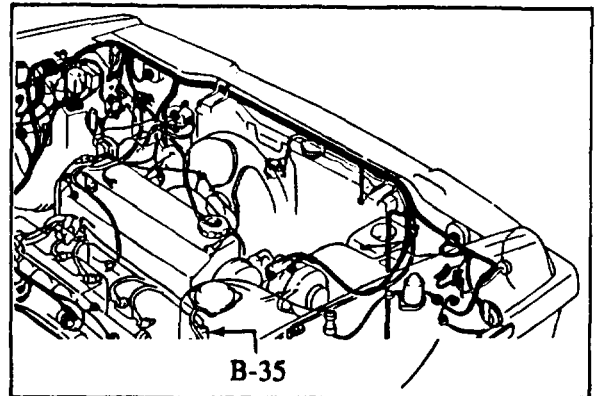
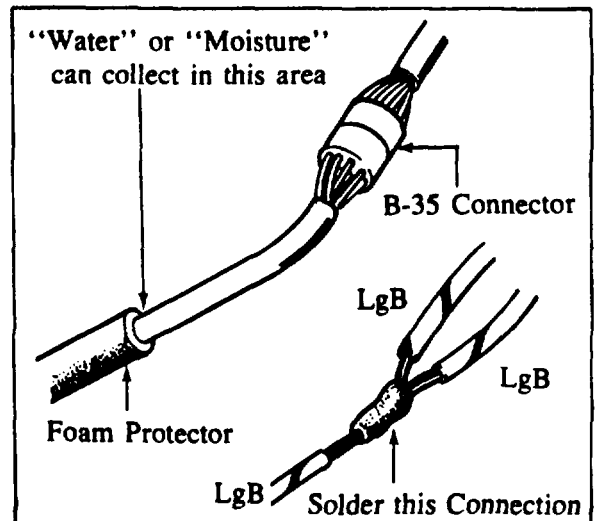
Check the point where the throttle sensor wires LgB, LgW and GO segments are joined by a crimp connection.

If it is rusted or moisture is found, solder these connectors and protect them with insulated tape. Make sure the harness is not touching the steering pipe. If the problem can not be solved after performing the above mentioned inspection, go to step G.

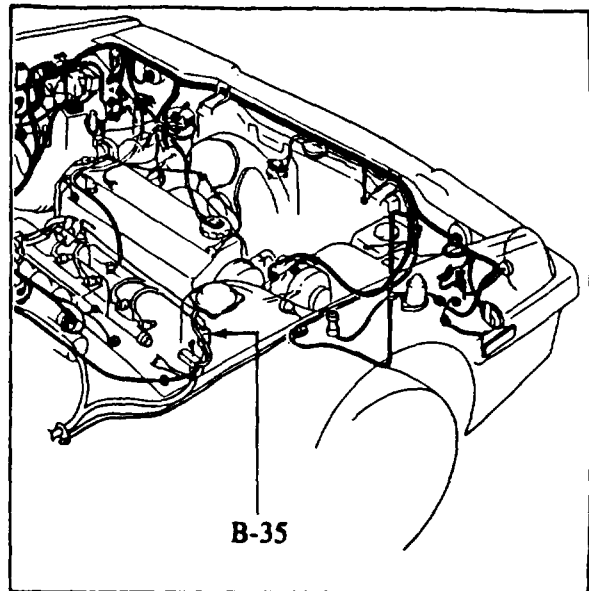
Check if the LgB, GO, LgW, LgR wires are properly connected at B-35 connector.

If the terminal is rusted or the harness is cut, clean up the terminal or repair the harness, then apply a suitable anti-rust agent.

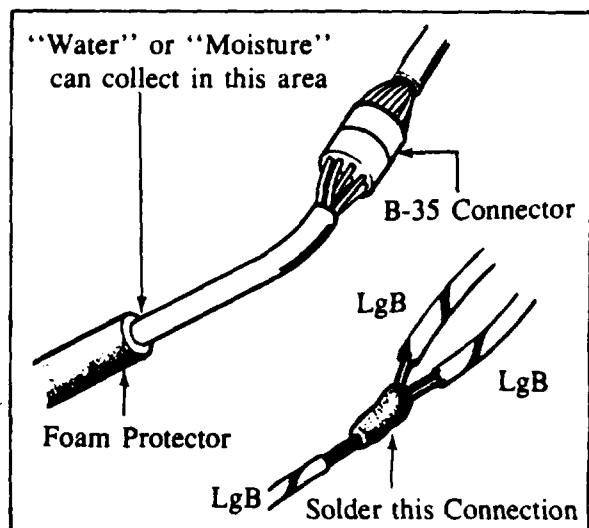
Inspect the EGI harness for water or a poor connection under the foam protector area near the B-35 connector.

Check the point where the throttle sensor wires LgB, LgW and GO segments are joined by a crimp connection.

If it is rusted or moisture is found, solder these connectors and protect them with insulated tape. Make sure the harness is not touching the steering pipe. If the problem can not be solved after performing the above mentioned inspection, go to step G.

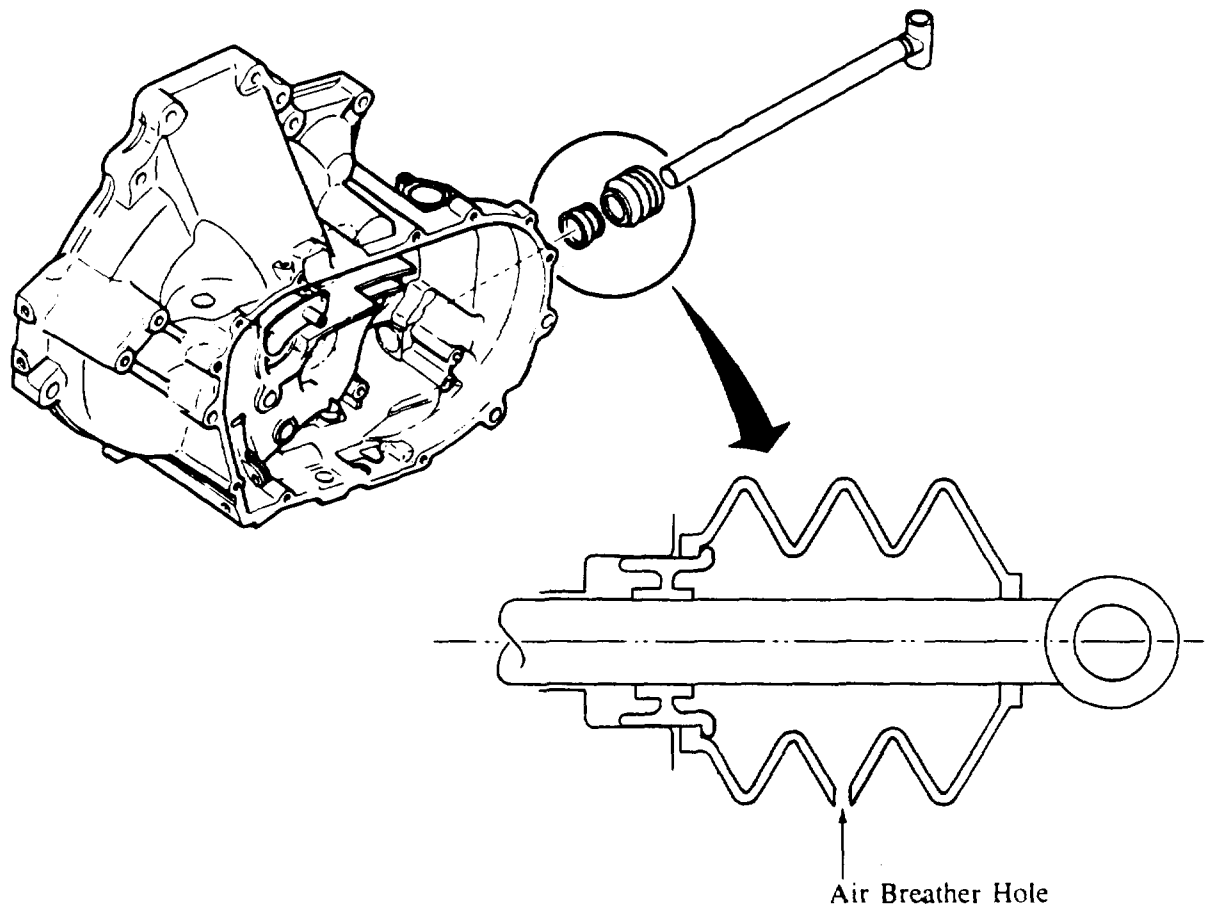
This is to prevent water or mud from collecting inside the boot through the air breather hole. If water or mud does come into the boot area, it will cause corrosion on the change rod and as a result, the oil seal will be damaged, which may cause oil leakage.

When you remove the change rod boot for repair, be sure to install it with the air breather hole directed downward.

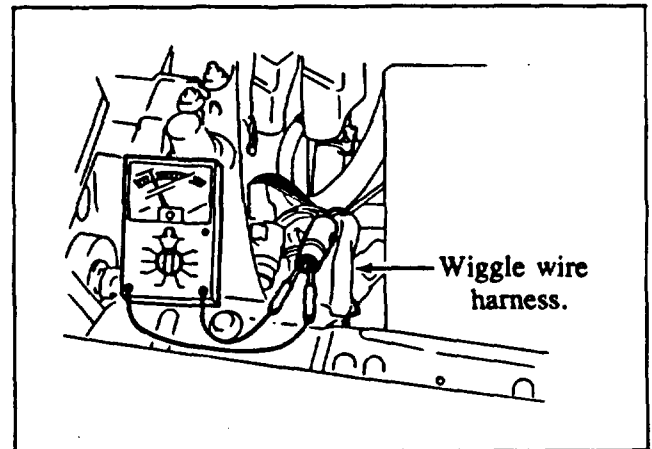
If a poor contact exists in the turbine sensor, resistance value changes and the value reads out of specification when wiggling the wire harness.

Model	Resistance Specification
626/MX-6	200-400 Ω
929	Approx. 245 Ω

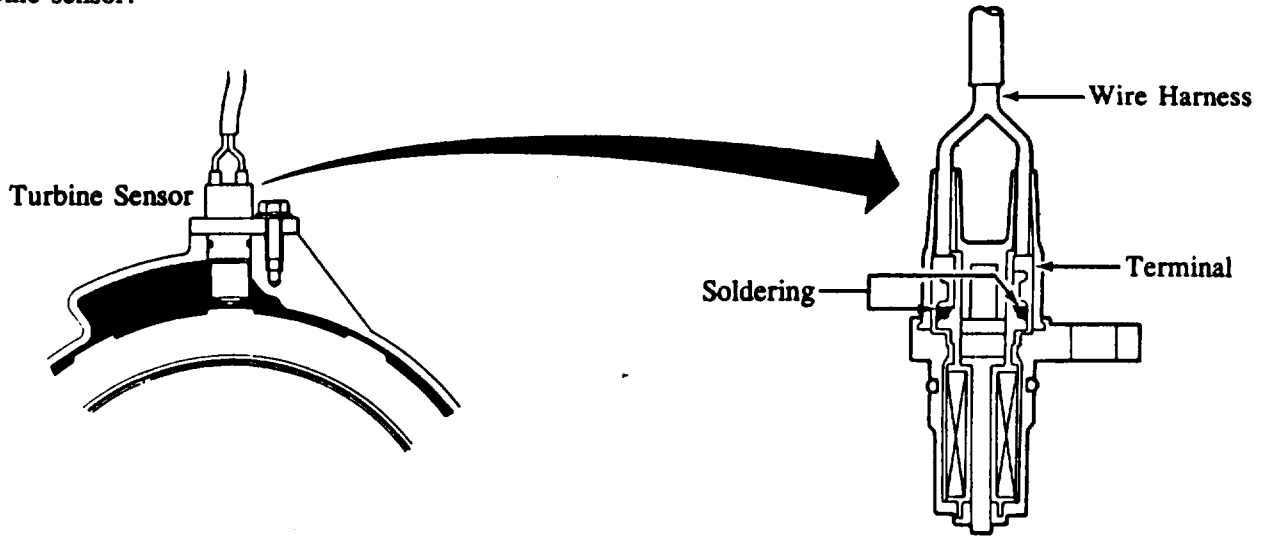
To improve this, a connection soldering process has been newly adopted to the wire harness and terminal of the turbine sensor.

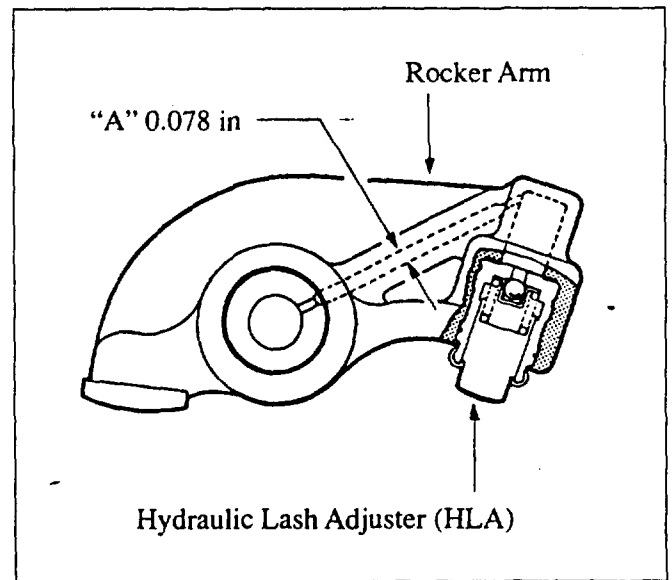
There are two different configurations for the Rocker Arm Assembly. See page B-63 in the 1990 Workshop Manual for more information.

- 1) When removed from the rocker arm shaft, inspect the contact area of the rocker arm. If it is scratched, replace the rocker arm shaft. Otherwise, due to oil pressure, leakage may result.
- 2) Please instruct customers to observe scheduled maintenance intervals. Inadequate amounts of oil or oil deterioration may cause the problem to reoccur.

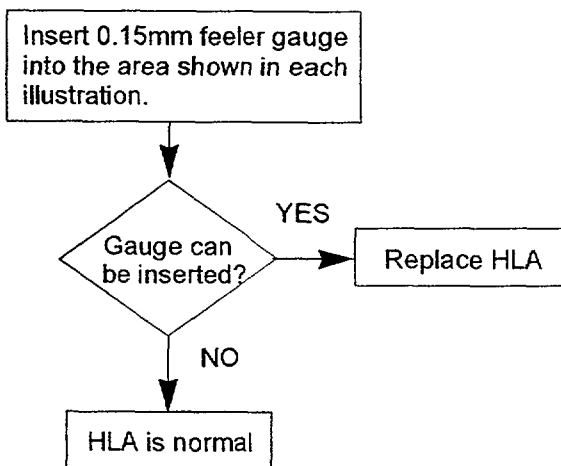
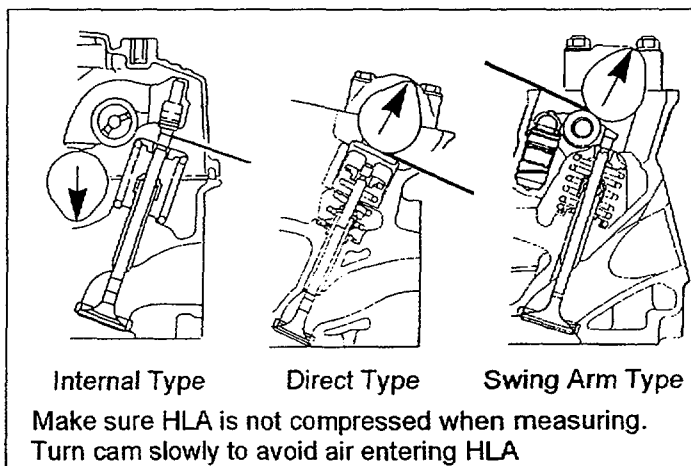
If the HLA is suspected as the cause of the noise item "c", identify the faulty HLA and replace **only those that require replacement**. Use the method below to determine which HLA requires replacement.

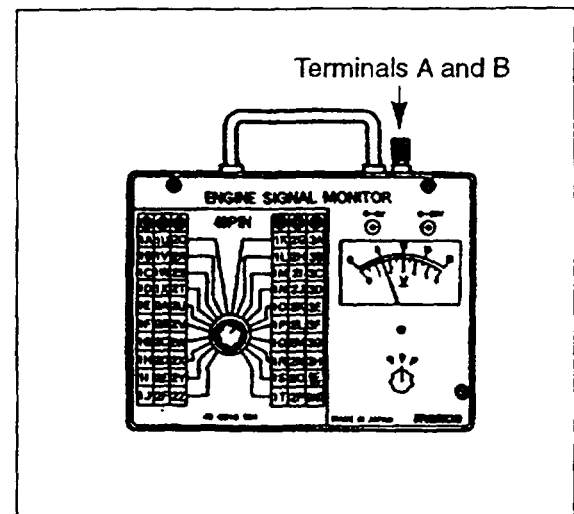
3. Measure the voltage according to the specifications in the workshop manual.
4. If the voltage is different than specified, check the related input and output devices and wiring for damage. If no problem is found and the reading remains out of specification, replace the ECU.
5. If the voltage is within specification and the problem still exists, contact the Technical Hotline for assistance.

CAUTION: Terminals A&B are for external voltmeter connections. Use these terminal to attach a digital voltmeter or oscilloscope for precise volt readings.

Never apply current to these terminals, damage to the ECU will result.

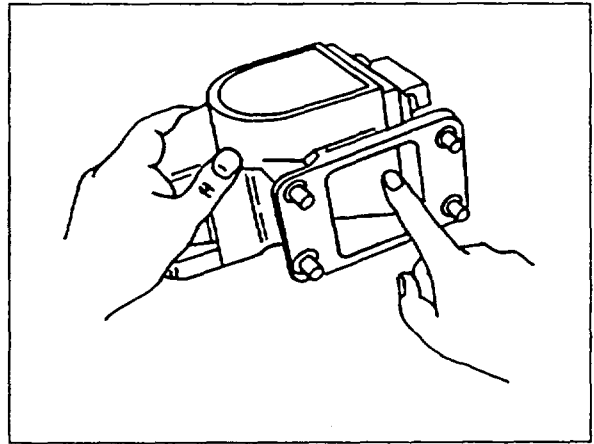
1. Check for smooth movement of the measuring plate.
If no problem is found, reinstall the air flow meter.
2. If no problem is found in the air flow meter, contact the Technical Hotline for assistance.

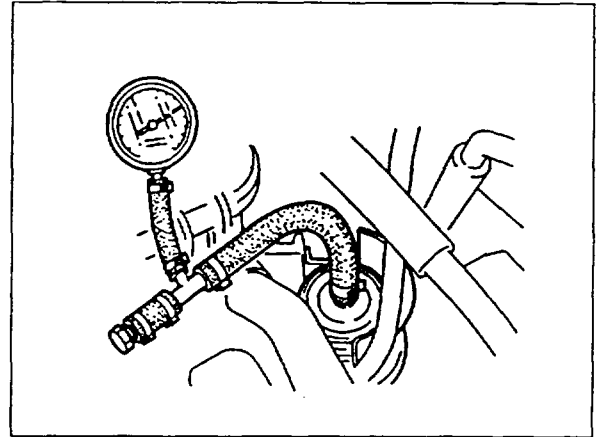
4. Disconnect the negative battery terminal.
5. Install the fuel pressure gauge on the outlet side of the fuel filter.
6. Short circuit the fuel pump test terminals (yellow 2 pin connector with a jumper wire on the following vehicles.

1988 - 89 323	1993 - 626/MX-6
1990 - 91 929	1989 - 92 MPV
1989 - 91 RX-7

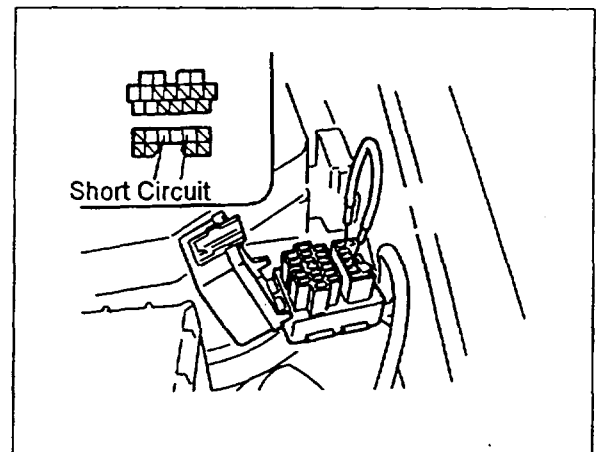
7. Short circuit the fuel pump check terminal and the ground terminal of the diagnostic connector with a jumper wire on the following vehicles.

1990 - 93 323/Protege	1993 626/MX-6
1992 - 93 929	1992 - 93 MX-3
1990 - 93 MX-5	1993 RX-7

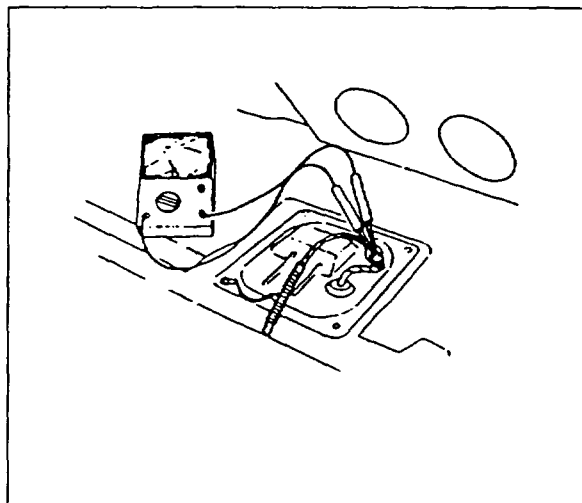
10. After restoring the standard voltage value, measure the fuel pump pressure (Max.). If pressure is not to specification, replace the fuel pump.

11. If no trouble is found with the fuel pump and the problem still exists, contact the Technical Hotline for assistance.

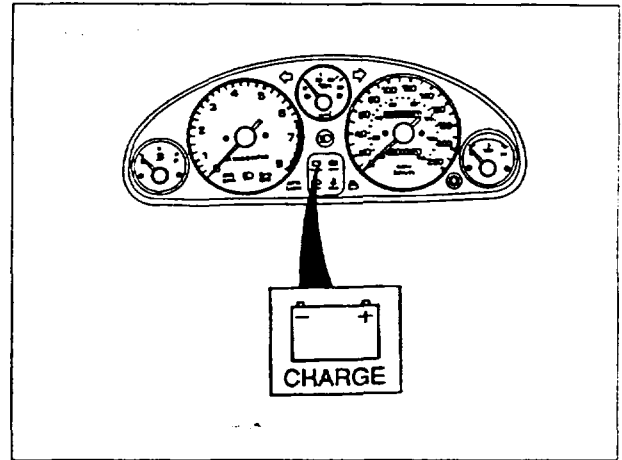
3. Turn off the ignition and all accessories. Connect a load tester (VAT-40 or equivalent).
4. Apply the load test referring to the chart to the right. The final voltage must be above the standard minimum value shown below.

Approx Battery Temperature	Minimum Voltage
70F (21C)	9.6V
60F (15C)	9.5V
50F (10C)	9.4V
40F (4C)	9.3V
30F (-1C)	9.1V
20F (-7C)	8.9V

If the voltage is below the minimum, quick charge the battery for 30 minutes and load test. If the battery remains below the minimum, replace the battery and proceed to step 4.

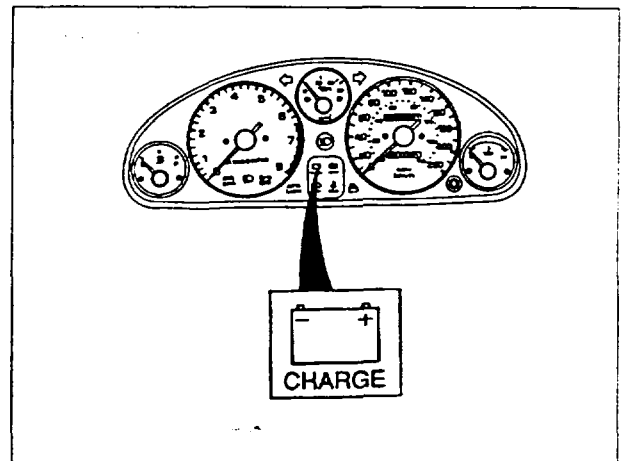
4. Apply the load test referring to the chart to the right. The final voltage must be above the standard minimum value shown below.

Approx Battery Temperature	Minimum Voltage
70F (21C)	9.6V
60F (15C)	9.5V
50F (10C)	9.4V
40F (4C)	9.3V
30F (-1C)	9.1V
20F (-7C)	8.9V

If the voltage is below the minimum, quick charge the battery for 30 minutes and load test. If the battery remains below the minimum, replace the battery and proceed to step 4.

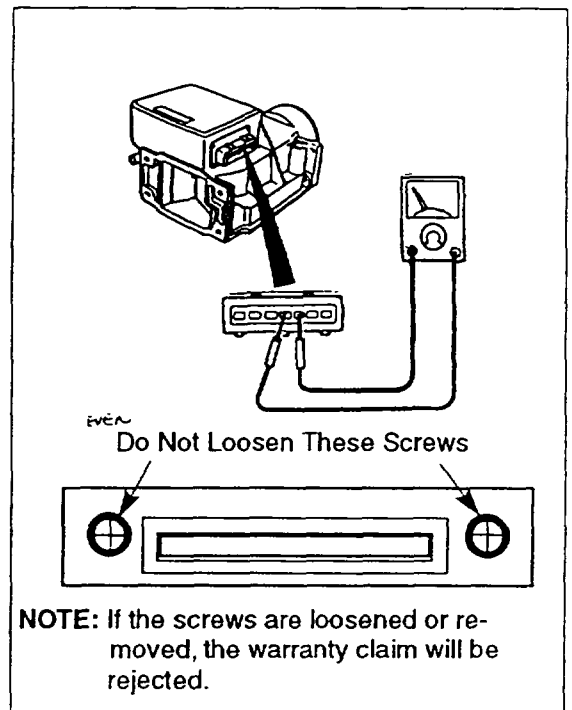
Section 2 - AIR FLOW METER DIAGNOSTIC PROCEDURES CONT'D.

1. Check for smooth movement of the measuring plate.
If no problem is found, reinstall the air flow meter.
2. If no problem is found in the air flow meter, contact the Technical Hotline for assistance.

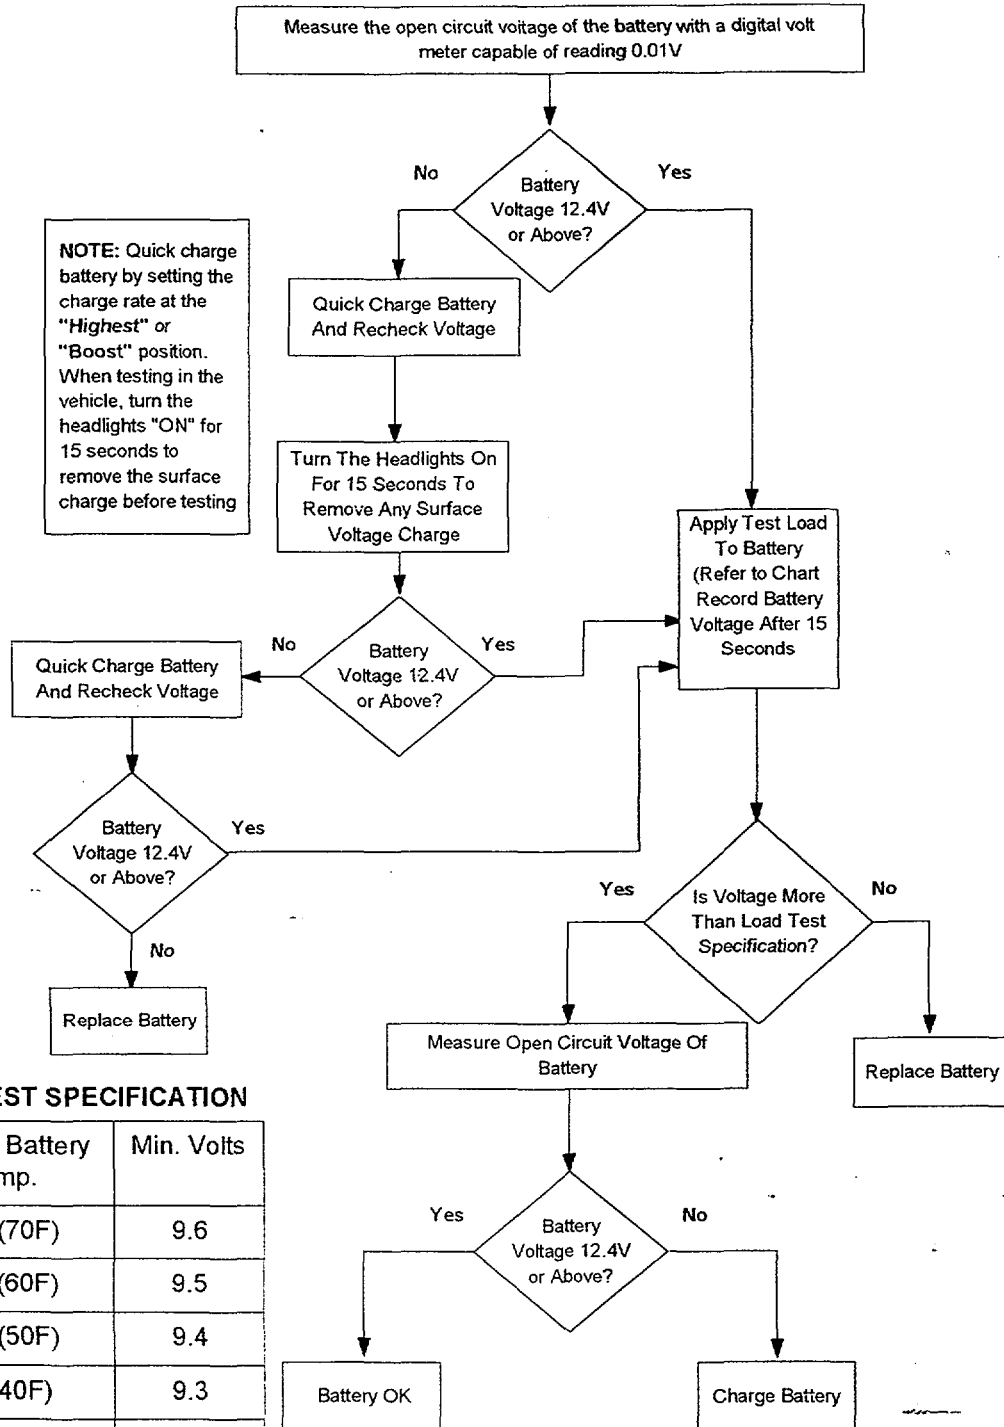
Diagnostic procedures used for testing lead-acid batteries provide false readings leading to unnecessary replacement if used on maintenance-free batteries. Follow the table below when diagnosing systems with maintenance-free batteries.

NOTE: Quick charge battery by setting the charge rate at the "Highest" or "Boost" position. When testing in the vehicle, turn the headlights "ON" for 15 seconds to remove the surface charge before testing

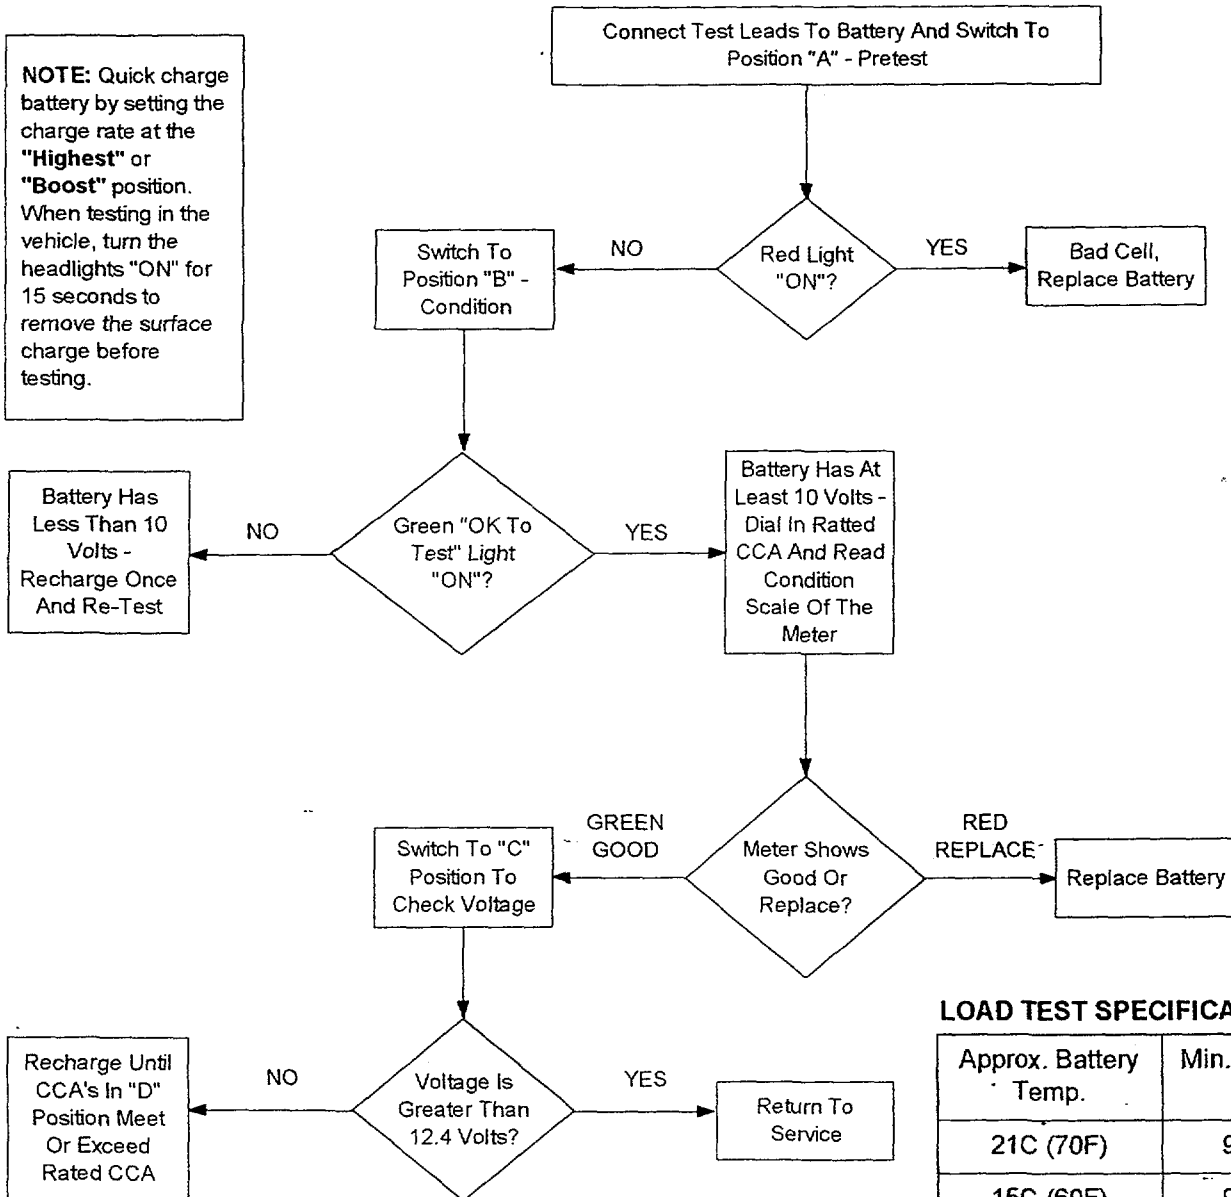
Diagnostic procedures used for testing lead-acid batteries provide false readings leading to unnecessary replacement if used on maintenance-free batteries. Follow the table below when diagnosing systems with maintenance-free batteries.

Approx. Battery Temp.	Min. Volts
21C (70F)	9.6
15C (60F)	9.5
10C (50F)	9.4
4C (40F)	9.3
-1C (30F)	9.1
-7C (20F)	8.9
-12C (10F)	8.7
-18C (0F)	8.5

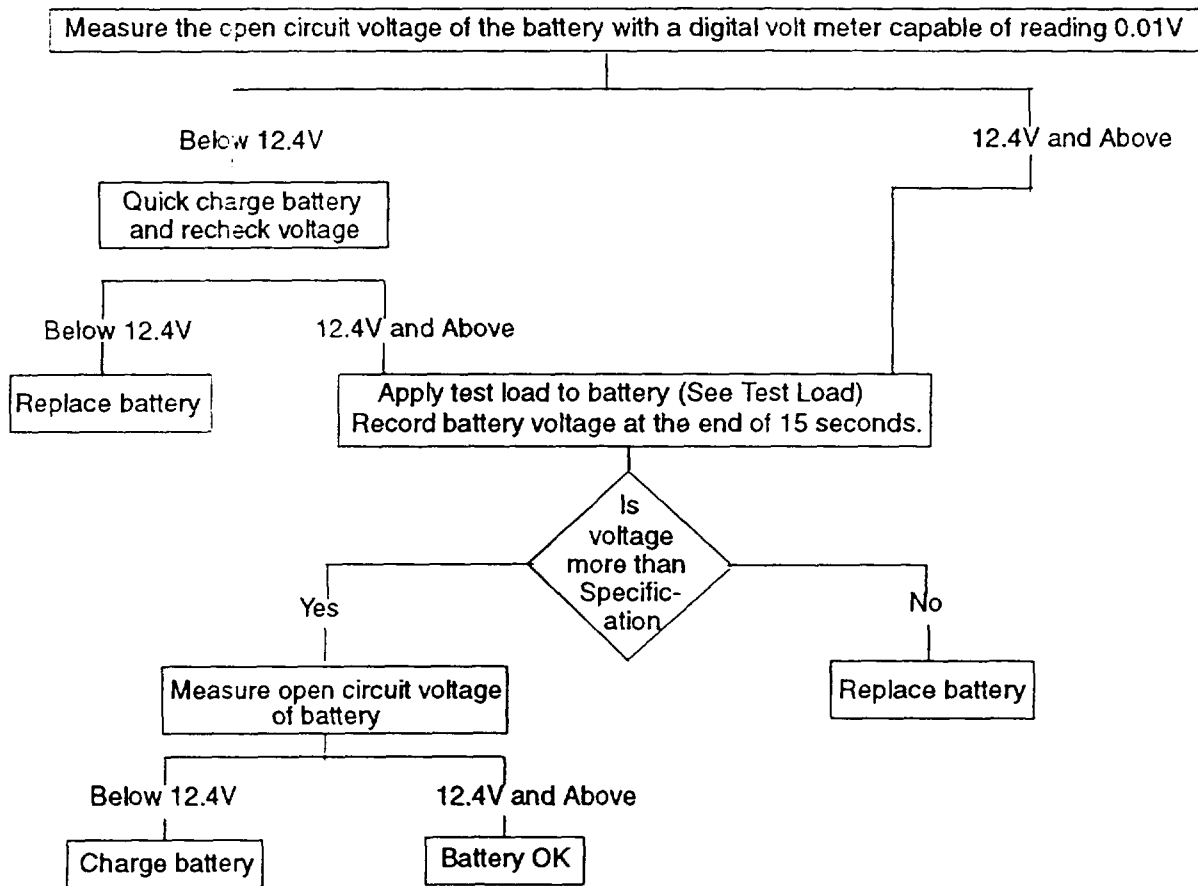
Because of their design, maintenance free batteries must not be diagnosed using procedures developed for lead storage batteries. This will provide a false reading and result in unnecessary replacement.

Approx. Battery Temp.	Min. Volts
21C (70F)	9.6
15C (60F)	9.5
10C (50F)	9.4
4C (40F)	9.3
-1C (30F)	9.1
-7C (20F)	8.9
-12C (10F)	8.7
-18C (0F)	8.5

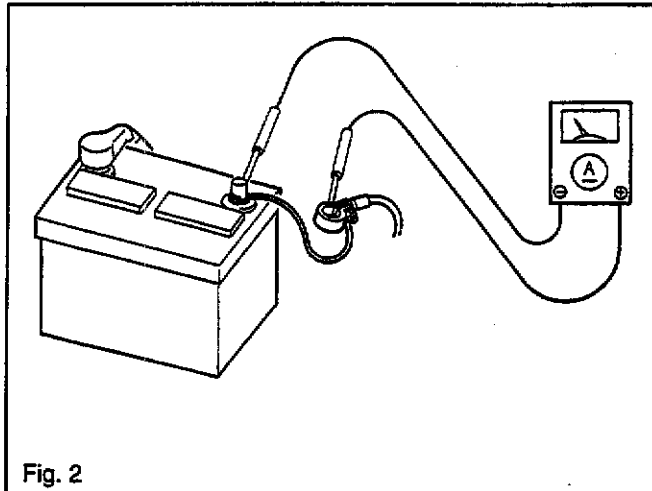
Change setting to 100 mA or 30 mA, disconnect the jumper wire and measure current.

8. If the current is more than 20 mA, perform the following:
- Disconnect the "ROOM" fuse and measure dark current.
 - Reconnect "ROOM" fuse to determine if current has changed.
 - If the current measurement is more than 2.5 mA, disconnect and connect each fuse to determine which circuit is drawing abnormal current.
9. Repair or replace faulty component(s) according to the workshop manual.

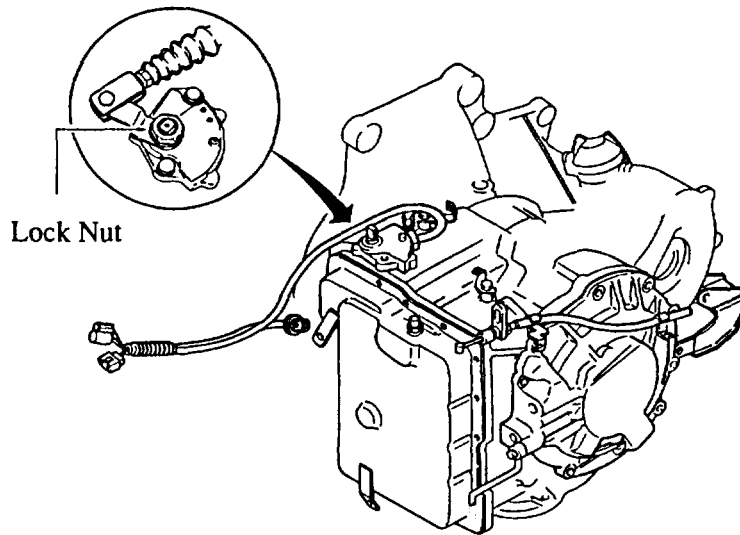
When tightening the manual shaft lock nut of the automatic transaxle, be sure to tighten it with the specified torque listed below.

1986-90 626	44-64 N-m (33-47 ft-lb, 4.5-6.5 kg-cm)
1988-89 323	44-64 N-m (33-47 ft-lb, 4.5-6.5 kg-cm)
1990 323/Protégé	31-46 N-m (23-34 ft-lb, 3.2-4.7 kg-cm)

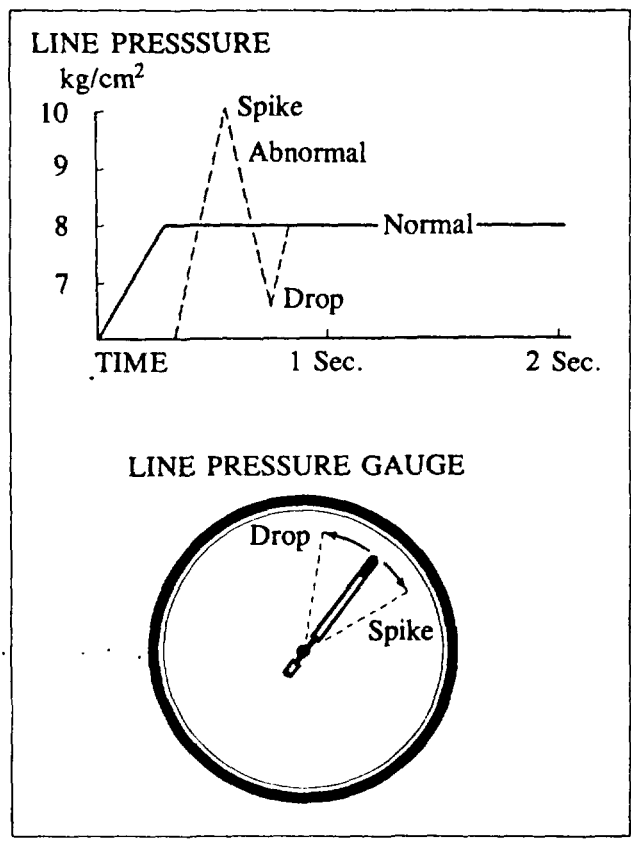
- A good oil pump should show a smooth increase of pressure and level off at a stable pressure.
 - If the spool valve of the oil pump is stuck, it may cause a pressure spike and variation in pressure before leveling off, or it may show little/no increase in pressure. (Refer to the illustrations.)

4. If a problem is found in Step 3, replace the oil pump spool valve according to the Replacement Procedure.
5. Recheck the line pressure according to Step 2 and perform the road test to confirm that the problem is fixed.
