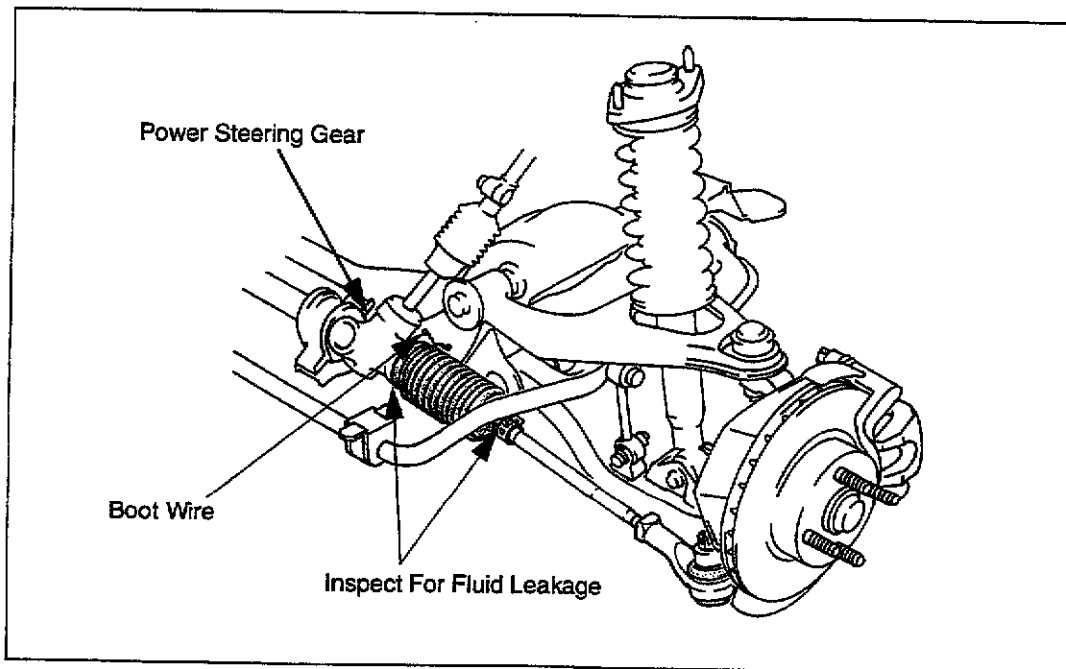
- If no fluid is leaking, no problem exists in the power steering gear.

CAUTION: DO NOT keep the steering wheel fully turned to the locked position for more than five (5) seconds. Power steering system damage may occur.

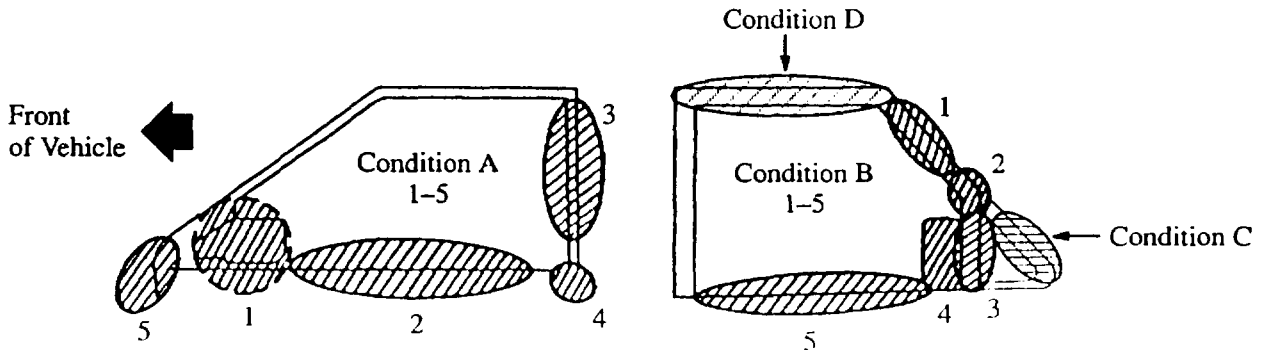
The illustration below shows the general areas where wind noise may occur (A-D). Specific locations of wind noise are shown numerically.

- A) Wind noise at front door area during high speed (above 40 mph) driving (pages 2 through 7).
- B) Wind noise at rear door area (pages 8 through 11).
- C) Wind noise/fluttering noise at rear corner window area (pages 11 and 12).
- D) Wind noise from front and rear door area due to window drop (page 13).

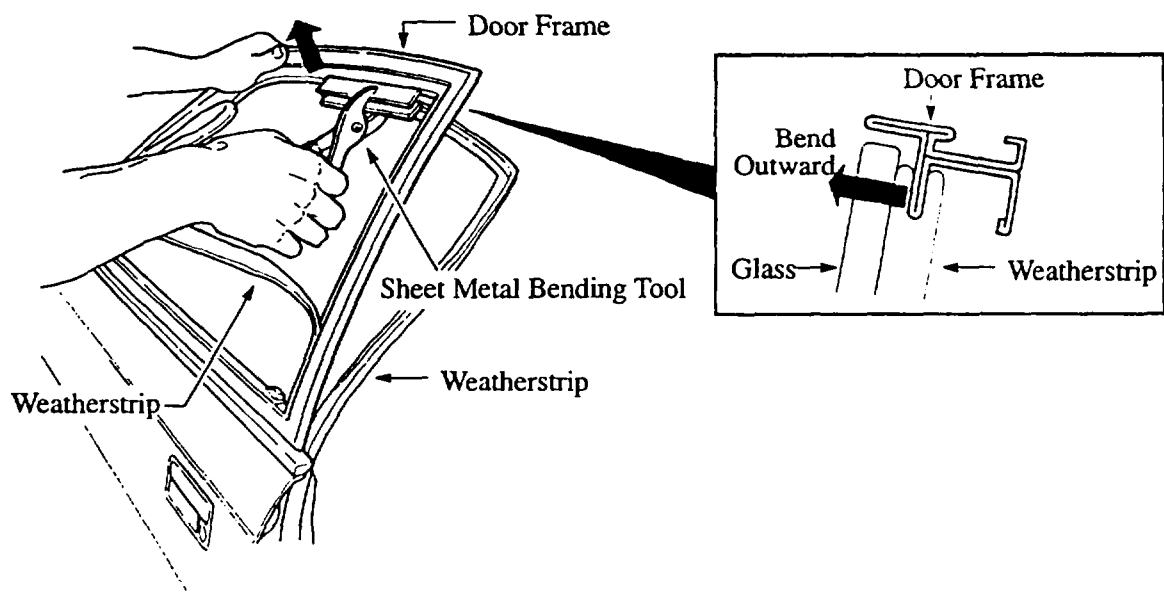
1. Use a business card as you would a feeler gauge to check for looseness (gaps) between the door glass and weatherstrip. The weatherstrip should press firmly against the glass around the entire door frame. Areas that do not form a tight seal between the glass and weatherstrip may allow the glass to drop thereby causing air leaks.
2. With the window in the down position, remove the following parts according to Workshop Manual procedures section S:
 - a) Black Plastic Inner Sail Garnish
 - b) Window Frame Weatherstrip
3. Remove the weatherstrip to access the glass run channel frame.
4. Carefully bend the weatherstrip frame slightly outward ($1/16''$) to increase the pressure of the weatherstrip against the glass. Use a sheet metal bending tool (Snap-on P/N VP8R or equivalent).

5. Install removed parts in the reverse order of removal.
6. Recheck the weatherstrip using the business card insertion technique.

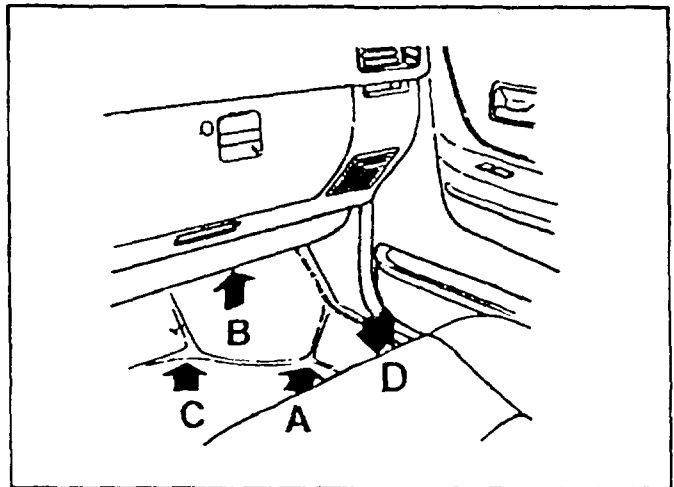
Figure 3: Possible Water Leak Areas

- AREA A: KICK PANEL (pages 3 and 4)
 AREA B: UNDER DASH (pages 4 and 5)
 AREA C: CORNER OF FIREWALL
 AND INNER FENDER (page 5)
 AREA D: OVER SILL PLATE (page 6)

6. Note which area the water enters the vehicle. Refer to the appropriate location's repair procedure. **Figure 3.**

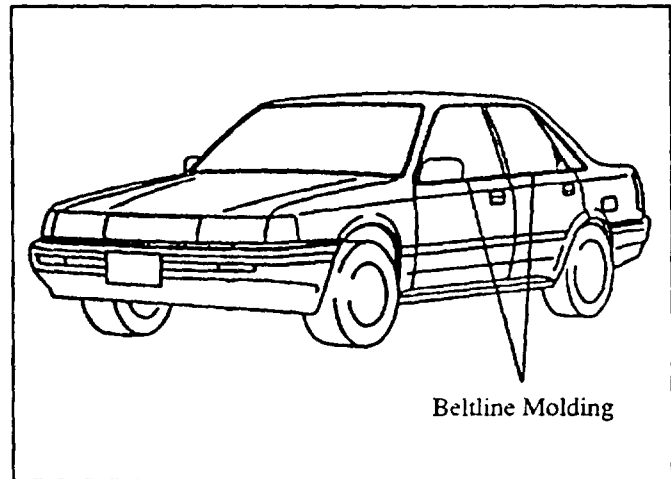
Figure 10: Area of Beltline Molding

NOTE: If Butyl sealer is hard or non-pliable, new sealer will need to be applied to the plastic sheeting to properly seal water leaking from these areas.

1. While an assistant directs water along the beltline molding, inspect for water entering from over the plastic sill plate. **Figure 10.**
2. If water is entering over the sill plate, remove the door panel and check that the plastic sheeting Butyl sealer is pressed firmly against the door frame. Also, check that no gaps are present between the sheet metal and the plastic.
3. Confirm that the door drain holes are draining properly and are not obstructed.

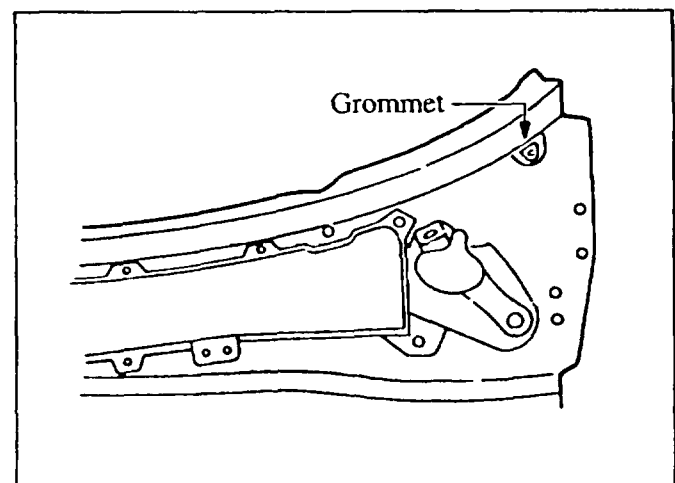
Figure 14: Left Side Grommet

NOTE: Only one grommet is located in an area where it may cause a water leak.

- Using a mechanic's mirror, look for signs of water leakage under the dash.
- Check the cowl grommet for leaks by spraying water on it. Replace the grommet if it leaks. Apply sealer to the bottom side of the grommet during installation. **Figure 14.**

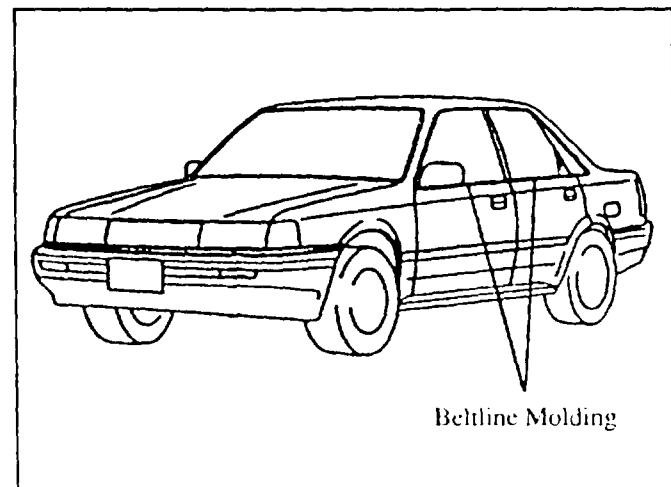
Figure 16: Area of Beltline Molding

NOTE: If Butyl sealer is hard or non-pliable, new sealer will need to be applied to the plastic sheeting to properly seal water leaking from these areas.

1. While an assistant directs water along the beltline molding, inspect for water entering from over the plastic sill plate. **Figure 16.**
2. If water is entering over the sill plate, remove the door panel and check that the plastic sheeting Butyl sealer is pressed firmly against the door frame. Also, check that no gaps are present between the sheet metal and the plastic.

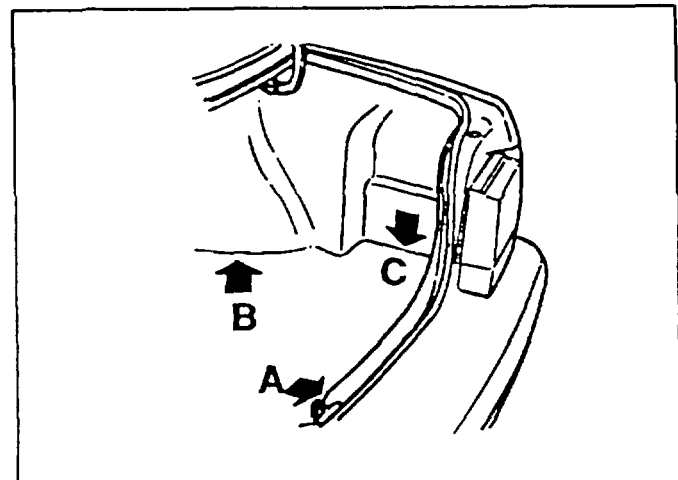
Figure 20: Locating Possible Water Leak Areas

7. Note which area the water enters the vehicle. Refer to the appropriate location's repair procedure. **Figure 20.**

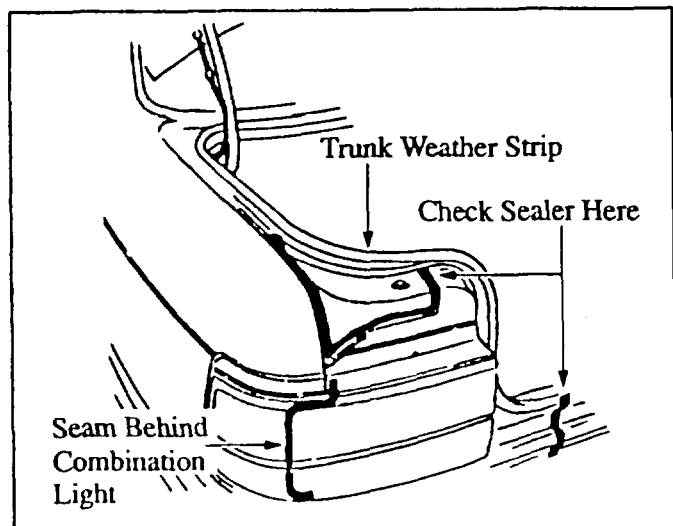
Figure 21: Inspecting Rear Trunk Area

2. If water is located behind the interior trunk end-panel trim or carpet, remove the trim panel. Direct a stream of water at the rear of the vehicle and pinpoint the location of the leak. Check the body seams for any pinholes or missing sealer. **Figure 21.**

4. If the leak is from the combination lamp(s) area, confirm that the mounting studs/nuts are tight and the assemblies are not cracked. Check end panel-to-quarter panel seams for any pinholes or missing sealer. If the leak continues, remove the combination lamp(s) and gasket(s). Install a new gasket to the combination lamp(s). **Figure 21.**

3. If pinholes and/or missing sealer are found in step 2, add a non-hardening grey body seam sealer to fill in the empty spots and reinstall the trunk weatherstrip. Make sure the trunk weatherstrip is routed under the latch striker and press it firmly in place. Retest for water leaks.

NOTE: Before installing the new gasket, apply sealer to both sides of the gasket. Also, confirm body-to-combination lamp surfaces are flush and no burrs are present.

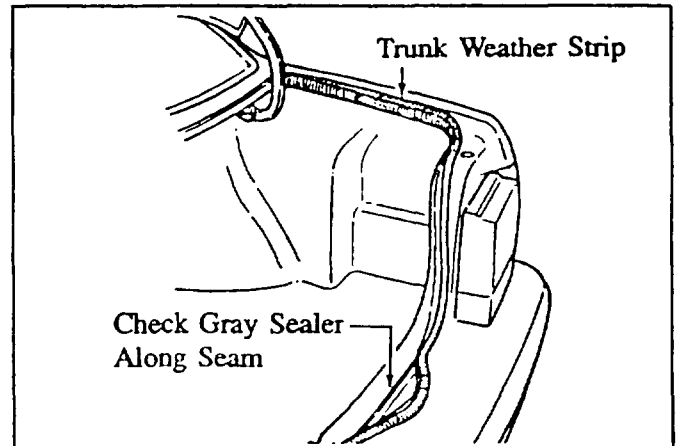
Figure 22: Checking Grey Sealer Under Trunk Weatherstrip

1. If water is running down over the interior trunk end-panel trim or over/under the trunk weatherstrip, pull up the trunk weatherstrip and check grey sealer material and any body seams near the linkage area. Confirm that grey sealer covers the top of the flange in one solid strip. Check for pinholes, missing sealer or burrs.

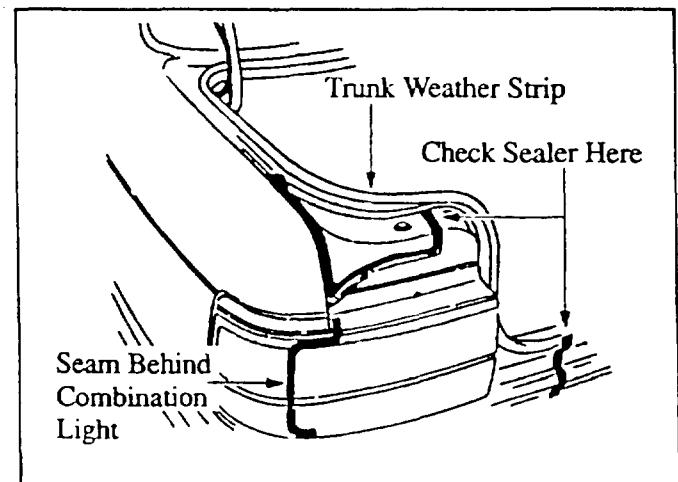
Figure 23: Inspecting Rear Trunk Area

1. If water leaks into the forward area of the trunk, make sure that the weatherstrip is properly seated and not leaking. **Figure 23.**
2. If no problems are found, check all trunk opening seams and the inner wheel well-to-trunk floor pan seam for missing sealer or pin holes. Seal any suspected areas and retest for leaks. If no problems are found, go to step 3.

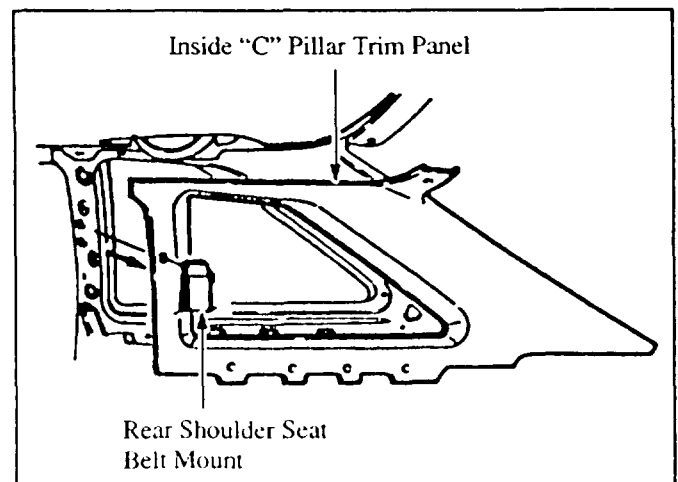
Figure 24: Removing Inside "C" Pillar Trim Panel

3. If necessary, remove the rear shoulder seat belt mounts and inside "C" pillar trim panel(s). Remove the mounting nuts. Next, remove the rear window glass side molding. **Figures 24 and 25.**

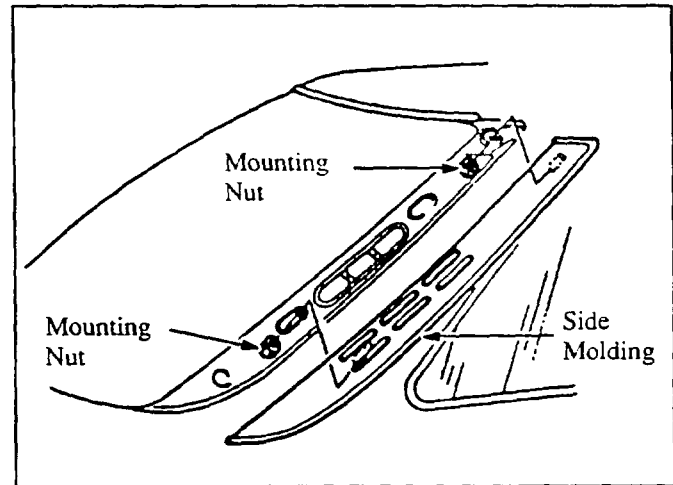
Figure 25: Removing Rear Window Glass Side Molding

4. Check the condition of the rear window sealer in this area. Use a flashlight to find small pinholes. Check extractor side molding mounting hardware for missing or damaged sealer or gaskets. Apply sealer to all mounting points as necessary. **Figure 25.**

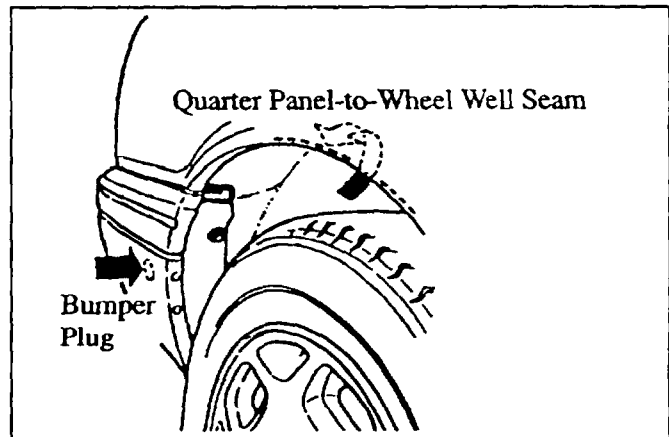
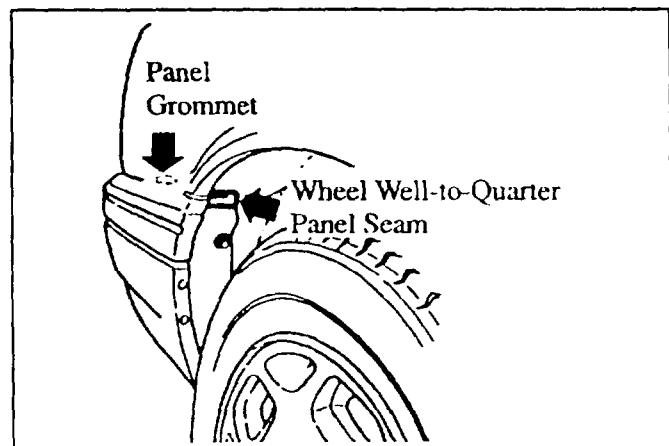
2. Check for any leaks at the grommet and plug between the quarter panel and bumper. Examine seams for missing sealer or pin holes. Seal any suspected defects. **Figures 26 and 27.**
3. Check for any leaks at the fuel filler neck-to-body in the left quarter. If moisture is present, remove the filler neck.
4. Apply sealer to both sides of the gasket and reinstall.

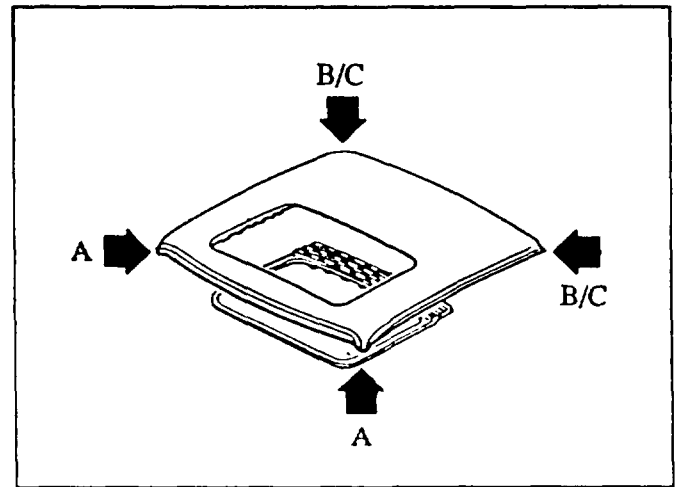
**Figure 28: Locating Source of Top Water Leaks**

1. Have an assistant help locate the exact point of water entry.
2. Turn the water pressure to the hose so that a 12" to 18" stream of water is present while the hose is in a vertical position.
3. Make sure the sunroof is completely closed.
If necessary, readjust sunroof.
(See Workshop Manual Section S.)
4. Run water over the sunroof and note in which area the water enters the vehicle. Refer to the appropriate location's repair procedure. **Figure 28.**

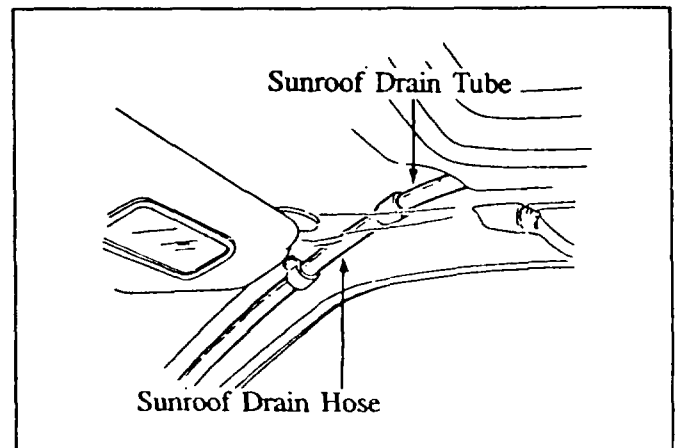
**Figure 29: Checking Front Drain Hose and Tube**

1. Open the sunroof and make sure that the sunroof drain tubes are intact and that no holes are present. If welds are damaged or have holes, repair or replace the sunroof frame.
2. If welds and drain tubes are OK, remove the front header and side trim pieces. Remove the headliner retainer clips (2 metal and 1 plastic per side), sunroof welt, and sun visor.
3. Carefully lower the headliner. Using a flashlight, check that the drain hose tubes are attached to the sunroof frame. **Figure 29.**
4. Direct a small stream of water into sunroof drain holes to make sure the drain tubes do not leak. If leaking is present, check for damaged hoses.
5. If the hoses are damaged, install a replacement piece of hose which provides a tight fit to the existing hose. The outside diameter of the replacement hose should be 9.5mm (3/8 in).

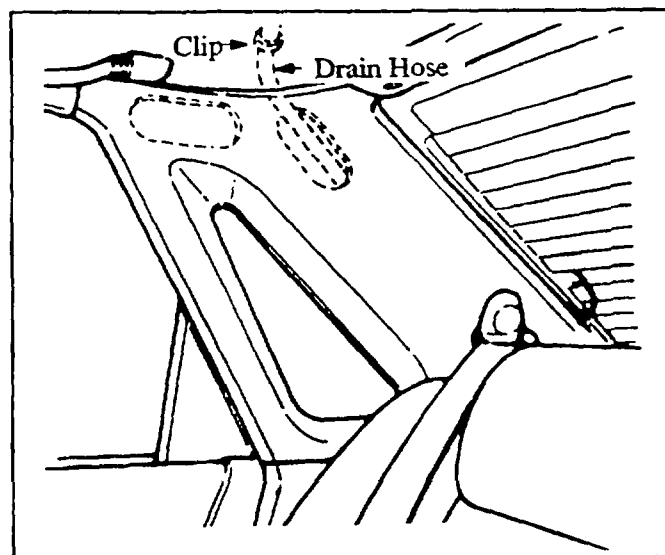
Figure 31: Rear Sunroof Drain Hose

4. Check that the drain hoses are attached to the sunroof drain tubes. Replace hose(s) as necessary. Check for kinks at the drain hose clip. **Figure 31.**

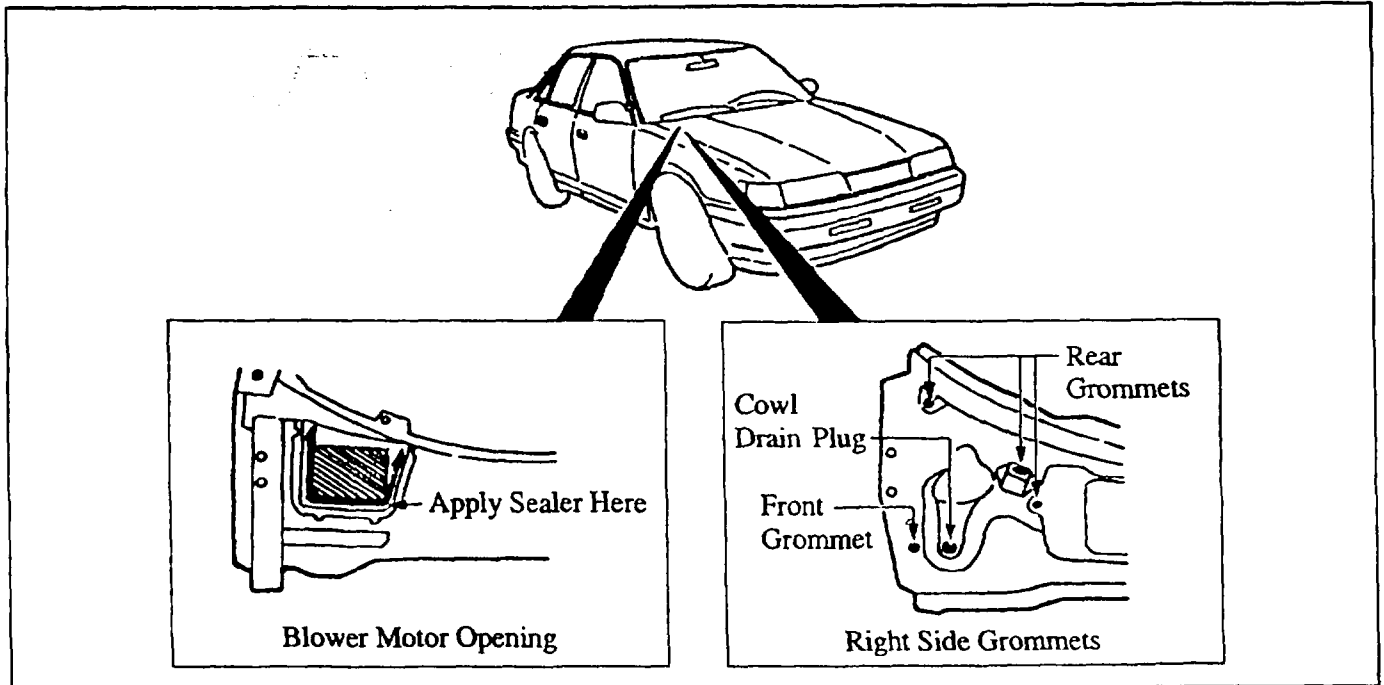
Figure 8: Checking Right Side Cowl for Leaks

1. Confirm that the upper cowl drain plug (black tube) has been modified (the dimension of the drain hole has been enlarged to 10mm). Also confirm that there are no obstructions and that the plug drains properly.
2. Using a mechanic's mirror, look for signs of water leakage under the dash (e.g. water/washer solvent stains).
3. Set the heater control air intake control lever to the first position. Remove the blower fan (3 screws) and look for water entering the blower motor opening.
4. Check all grommets shown in Figure 8 for leaks by spraying water on each one. Replace any grommets that leak.

5. If the grommets do not leak, seal the baffle seam by reaching up through the blower motor opening and seal the areas indicated in Figure 8.
6. If water is leaking from the the firewall, check for studs and grommets that might be loose or improperly seated on the engine side of the firewall. If necessary, remove, redress, and reinstall the studs. Retap the holes and, if necessary, replace the bolts. Apply sealer to the threads before installing the bolts. Apply silicone sealer to the bottom of the grommets prior to installation.

7. If a leak is found, remove the black plastic cowl vent, then remove the foam strip from the underside.
NOTE: Before installing the new foam pads, make sure to apply sealer to both sides of the pad.
8. Reinstall the black plastic cowl vent. Perform a water leak test by directing water around the outer edges of the cowl vent. Inspect for water leakage or moisture.

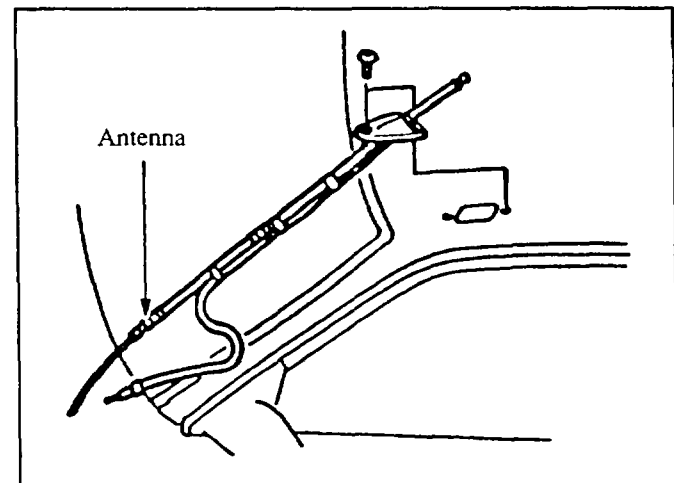
Figure 13: Inspecting Antenna Bezel

1. Follow the same repair procedure described for the right front side of the passenger compartment.
2. Run water on the antenna. Make sure the antenna tube is intact on the bottom of the power antenna motor and water drains properly (for models equipped with power antenna.)
3. If necessary, position the hose so there are no loops, kinks or pinched areas. If the hose cannot be corrected or is out, remove the damaged section of hose. Install a replacement piece of hose (4.7 mm [3/16 in.] outside diameter) which provides a tight fit to the existing hose.
4. If the leak persists, inspect the antenna bezel molding and gasket for correct sealing and mounting. Confirm that the mounting screw is fully seated and that the gasket is firmly contacting the roof sheet metal. **Figure 13.**

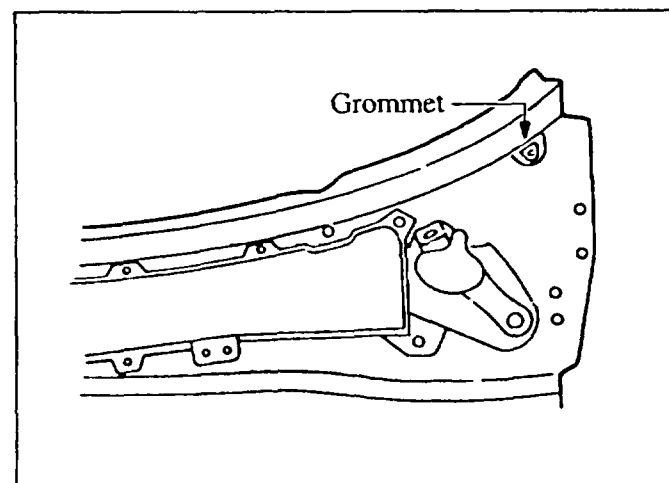
Figure 14: Left Side Grommet

1. Using a mechanic's mirror, look for signs of water leakage under the dash.
2. Check the cowl grommet for leaks by spraying water on it. Replace the grommet if it leaks. Apply sealer to the bottom side of the grommet during installation. **Figure 14.**

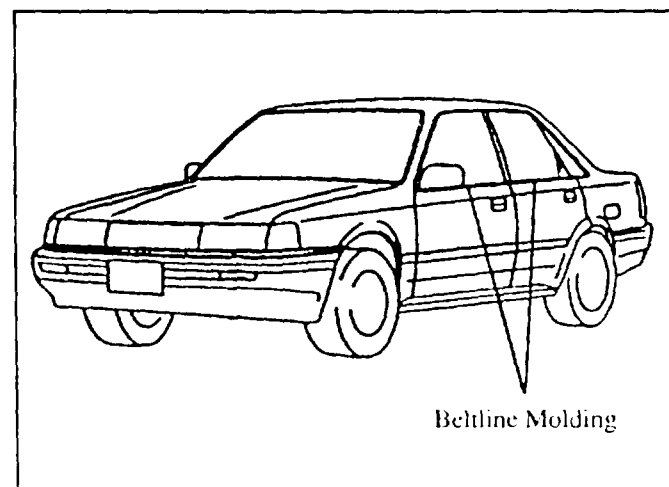
Figure 16: Area of Beltline Molding

1. While an assistant directs water along the beltline molding, inspect for water entering from over the plastic sill plate. **Figure 16.**
2. If water is entering over the sill plate, remove the door panel and check that the plastic sheeting Butyl sealer is pressed firmly against the door frame. Also, check that no gaps are present between the sheet metal and the plastic.

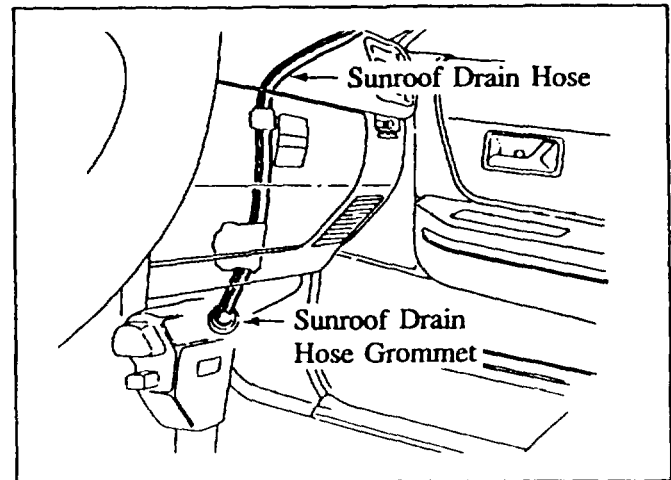
Figure 4: Checking the Sunroof Drain Hose

1. Remove kick panel and inspect.
2. Make sure that the door electrical harness boot and the sunroof drain hose grommet are seated. Check that the sunroof drain hose is not kinked and extends through the lower kick panel.

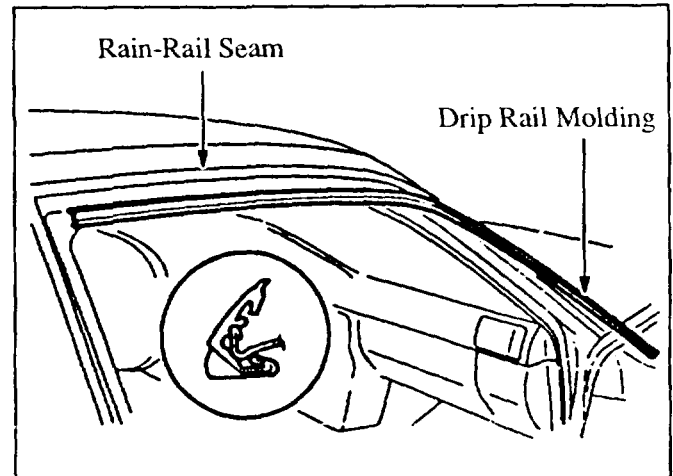
Figure 5: Drip Rail Molding

3. Remove the drip-rail molding and inspect rain-rail seams for missing sealer or pinholes. Seal any suspected sealer defects. Figure 5.
4. Open the sunroof. Using a squeeze bottle filled with water, pour water down the front drain holes. Check for signs of leakage at the sunroof drain tube-to-drain hose.

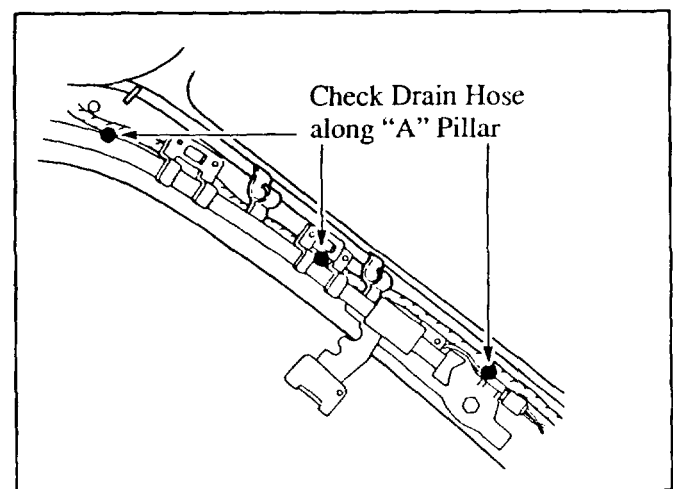
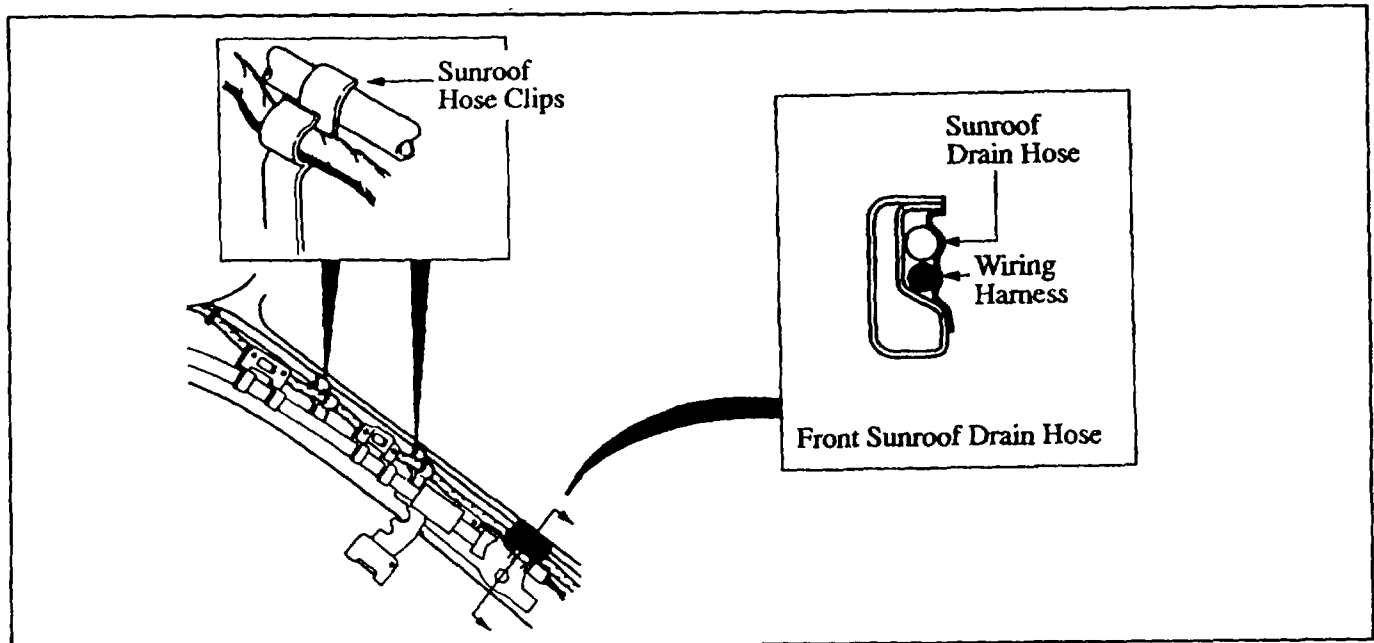
5. If the leak is still present, remove cap and screw from the front windshield header. Remove the "A" pillar side molding. Check the drain hose for kinks. Figure 6.
6. If necessary, reposition the hose so that there are no loops, kinks or pinched areas. Repeat the water test. Make sure that the sunroof drains properly with no leaks. Figure 7.

7. If necessary, remove the damaged section of hose. Install a replacement piece of hose with a 9.5mm (3/8 inch) outside diameter which provides a tight fit to the existing hose.

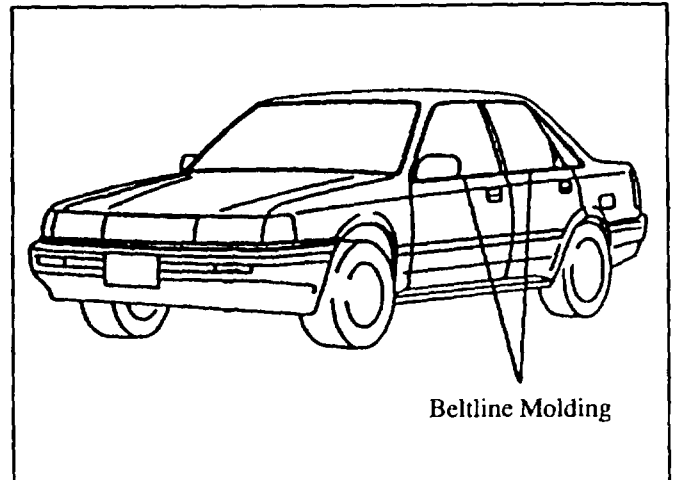
Figure 10: Area of Beltline Molding

1. While an assistant directs water along the beltline molding, inspect for water entering from over the plastic sill plate. **Figure 10.**
2. If water is entering over the sill plate, remove the door panel and check that the plastic sheeting Butyl sealer is pressed firmly against the door frame. Also, check that no gaps are present between the sheet metal and the plastic.
3. Confirm that the door drain holes are draining properly and are not obstructed.

Note: If Butyl sealer is hard or non-pliable, new sealer will need to be applied to the plastic sheeting to properly seal water leaking from these areas.

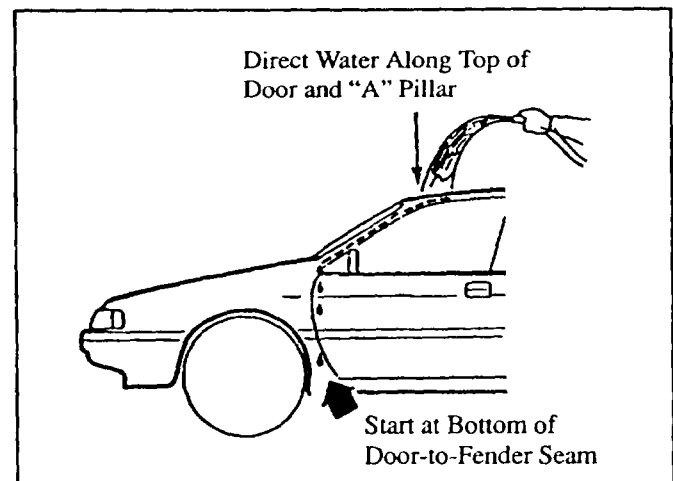
Figure 11: Locating Source of Front Water Leak

5. With the door closed, watch for water leaks during the hose test. Have an assistant slowly direct the water stream up from the bottom portion of the door-to-fender seam then up the "A" pillar to the top of the door and around the windshield. Next, have the assistant slowly direct water along the window beltline molding (if the vehicle is a four door, perform this test on both the front and rear doors.) **Figures 10 and 11.**

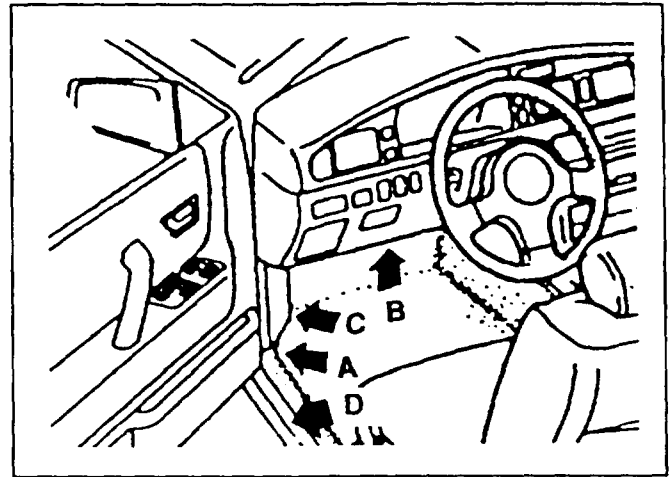
Figure 12: Possible Water Leak Areas

6. Note which area the water enters the vehicle. Refer to the appropriate location's repair procedure. **Figure 12.**

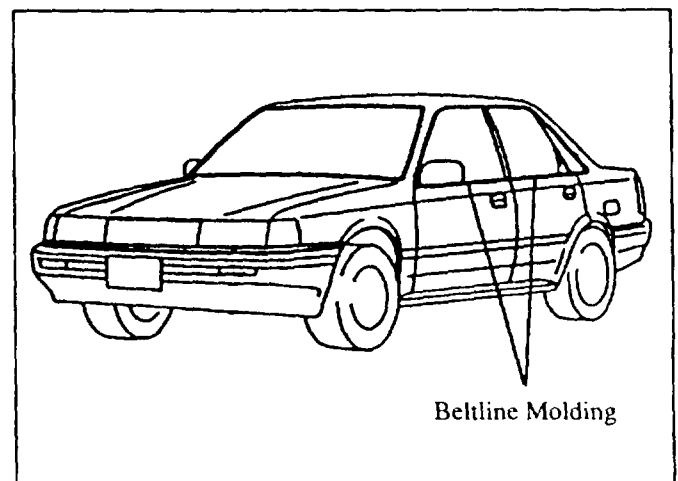
Figure 16: Area of Beltline Molding

1. While an assistant directs water along the beltline molding, inspect for water entering from over the plastic sill plate. **Figure 16.**
2. If water is entering over the sill plate, remove the door panel and check that the plastic sheeting Butyl sealer is pressed firmly against the door frame. Also, check that no gaps are present between the sheet metal and the plastic.

Note: If Butyl sealer is hard or non-pliable, new sealer will need to be applied to the plastic sheeting to properly seal water leaking from these areas.

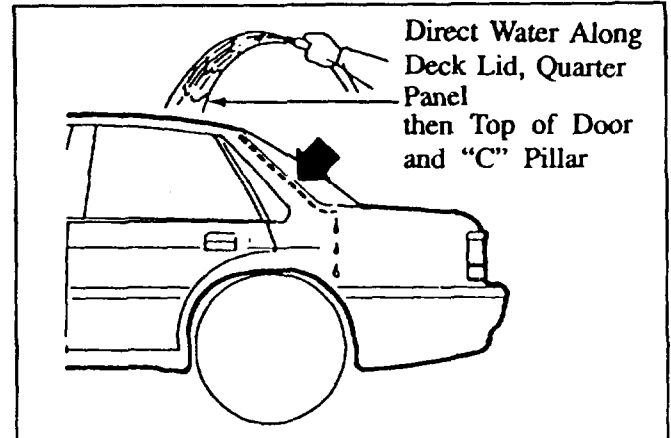
Figure 17: Locating Source of Rear Water Leak

Note: Direct a heavy stream of water where the rocker panel meets the inner wheel well (to check for leakage into the rocker panel). **Figure 17.**

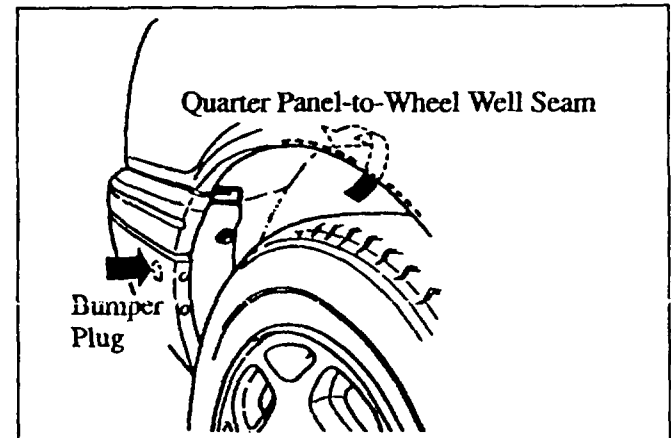
Figure 18: Bumper Plug and Wheel Test Area

- Inner wheel well-to-quarter panel seam and bumper plug. **Figure 18.**
- Inner wheel well-to-trunk floor pan seam. **Figure 19.**
- Inner wheel well-to-floor pan seam (to check for leakage under the rear seat.)

2. Check for any leaks at the grommet and plug between the quarter panel and bumper. Examine seams for missing sealer or pin holes. Seal any suspected defects. **Figures 26 and 27.**
3. Check for any leaks at the fuel filler neck-to-body in the left quarter. If moisture is present, remove the filler neck.
4. Apply sealer to both sides of the gasket and reinstall.

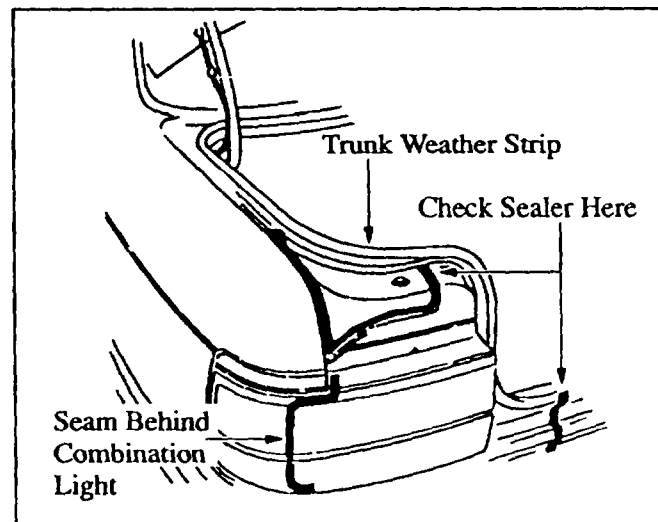
Figure 21: Inspecting Rear Trunk Area

2. If water is located behind the interior trunk end-panel trim or carpet, remove the trim panel. Direct a stream of water at the rear of the vehicle and pinpoint the location of the leak. Check the body seams for any pinholes or missing sealer. **Figure 21.**

- If the leak is from the combination lamp(s) area, confirm that the mounting studs/nuts are tight and the assemblies are not cracked. Check end panel-to-quarter panel seams for any pinholes or missing sealer. If the leak continues, remove the combination lamp(s) and gasket(s). Install a new gasket to the combination lamp(s). Figure 21.

3. If pinholes and/or missing sealer are found in step 2, add a non-hardening grey body seam sealer to fill in the empty spots and reinstall the trunk weatherstrip. Make sure the trunk weatherstrip is routed under the latch striker and press it firmly in place. Retest for water leaks.

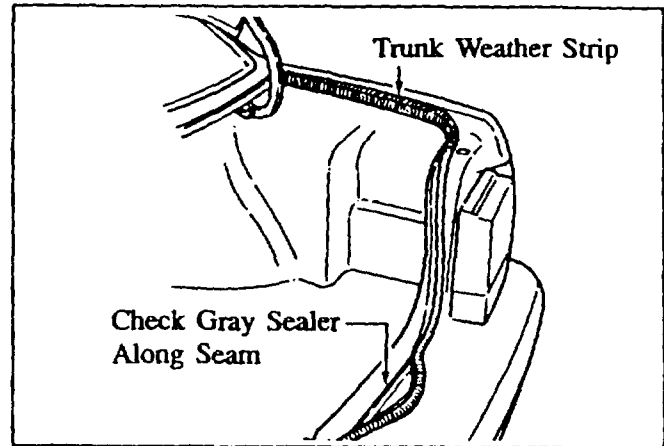
Figure 22: Checking Grey Sealer Under Trunk Weatherstrip

1. If water is running down over the interior trunk end-panel trim or over/under the trunk weatherstrip, pull up the trunk weatherstrip and check grey sealer material and any body seams near the linkage area. Confirm that grey sealer covers the top of the flange in one solid strip. Check for pin holes, missing sealer or burrs. **Figure 21** and **Figure 22.**

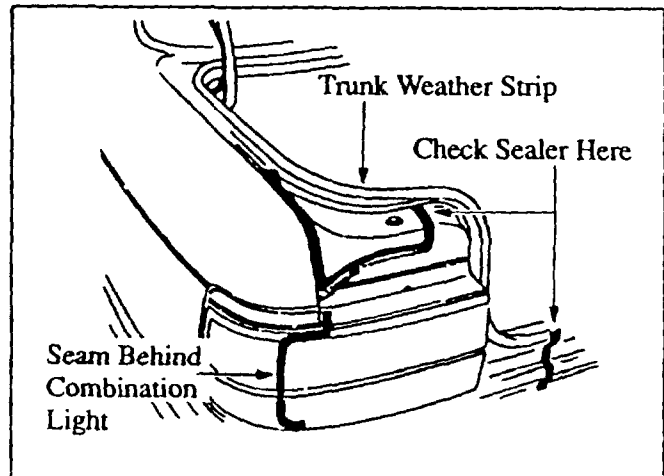
Figure 23: Inspecting Rear Trunk Area

- If water leaks into the forward area of the trunk, make sure that the weatherstrip is properly seated and not leaking. Figure 23.
- If no problems are found, check all trunk opening seams and the inner wheel well-to-trunk floor pan seam for missing sealer or pin holes. Seal any suspected areas and retest for leaks. If no problems are found, go to step 3.

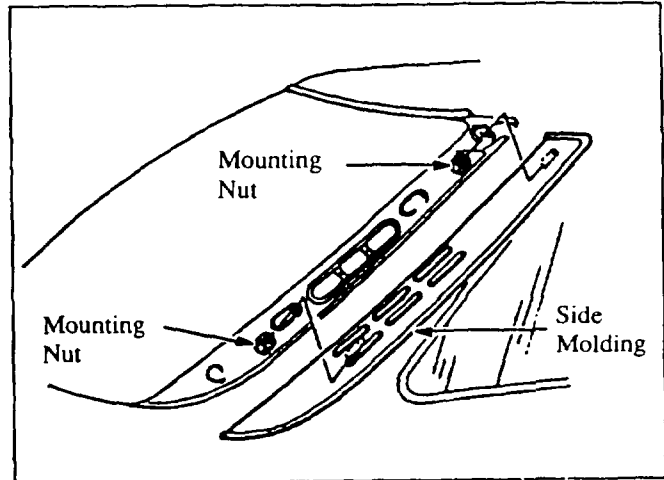
Figure 25: Removing Rear Window Glass Side Molding

4. Check the condition of the rear window sealer in this area. Use a flashlight to find small pinholes. Check extractor side molding mounting hardware for missing or damaged sealer or gaskets. Apply sealer to all mounting points as necessary. **Figure 25.**

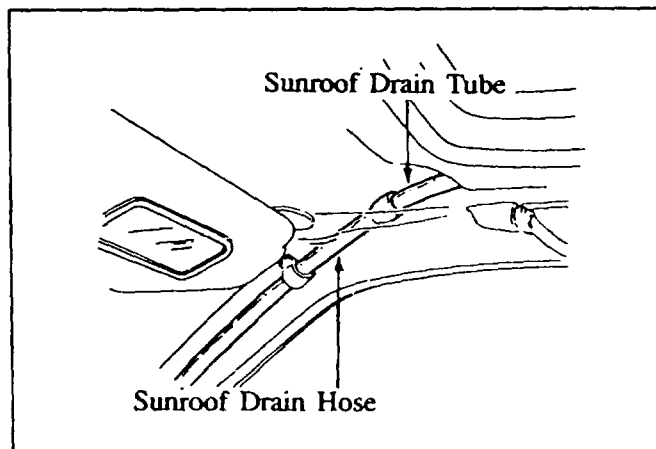
Figure 29: Checking Front Drain Hose and Tube

1. Open the sunroof and make sure that the sunroof drain tubes are intact and that no holes are present. If welds are damaged or have holes, repair or replace the sunroof frame.
2. If welds and drain tubes are OK, remove the front header and side trim pieces. Remove the headliner retainer clips (2 metal and 1 plastic per side), sunroof welt, and sun visor.
3. Carefully lower the headliner. Using a flashlight, check that the drain hose tubes are attached to the sunroof frame. **Figure 29.**
4. Direct a small stream of water into sunroof drain holes to make sure the drain tubes do not leak. If leaking is present, check for damaged hoses.
5. If the hoses are damaged, install a replacement piece of hose which provides a tight fit to the existing hose. The outside diameter of the replacement hose should be 9.5mm (3/8 in).

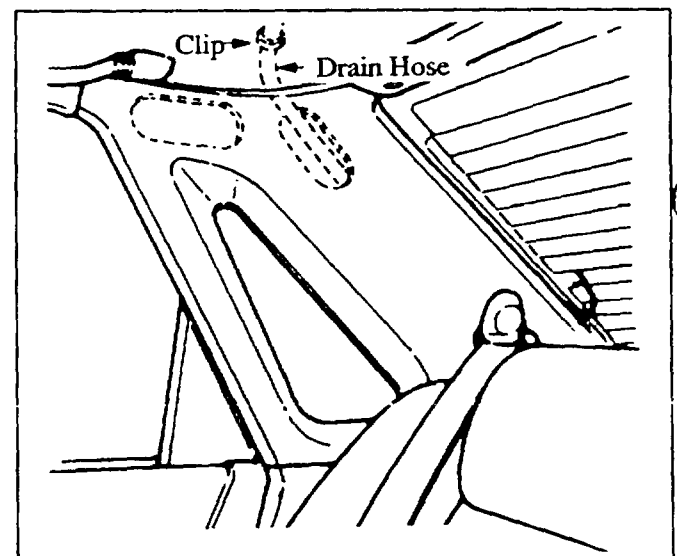
Figure 31: Rear Sunroof Drain Hose

4. Check that the drain hoses are attached to the sunroof drain tubes. Replace hose(s) as necessary. Check for kinks at the drain hose clip. **Figure 31.**

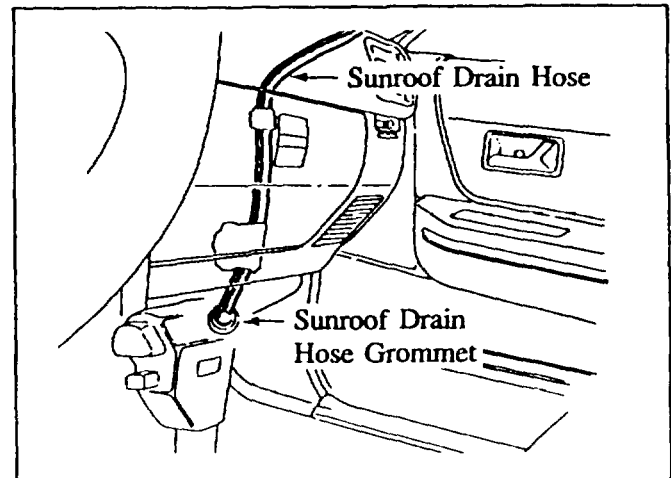
Figure 4: Checking the Sunroof Drain Hose

1. Remove kick panel and inspect.
2. Make sure that the door electrical harness boot and the sunroof drain hose grommet are seated. Check that the sunroof drain hose is not kinked and extends through the lower kick panel.

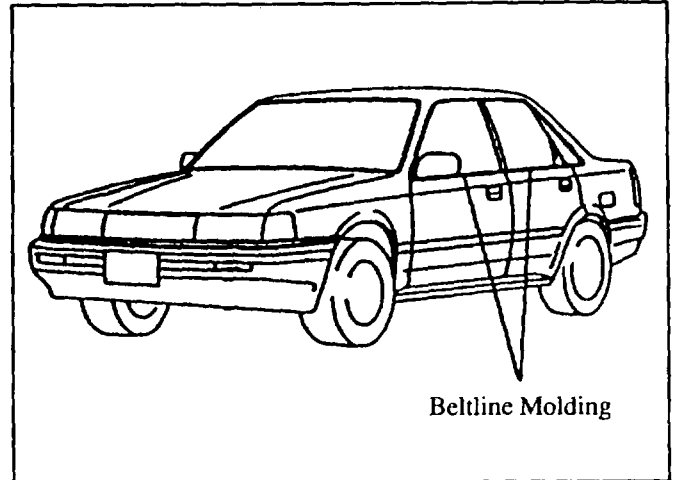
Figure 10: Area of Beltline Molding

1. While an assistant directs water along the beltline molding, inspect for water entering from over the plastic sill plate. **Figure 10.**
2. If water is entering over the sill plate, remove the door panel and check that the plastic sheeting Butyl sealer is pressed firmly against the door frame. Also, check that no gaps are present between the sheet metal and the plastic.
3. Confirm that the door drain holes are draining properly and are not obstructed.

Note: If Butyl sealer is hard or non-pliable, new sealer will need to be applied to the plastic sheeting to properly seal water leaking from these areas.

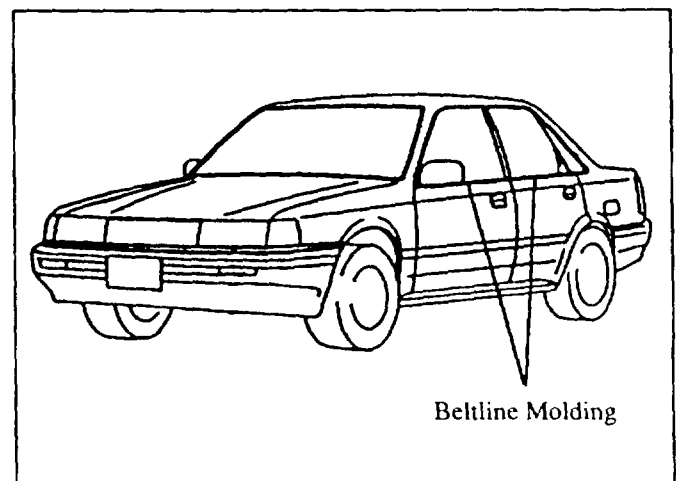
Figure 16: Area of Beltline Molding

1. While an assistant directs water along the beltline molding, inspect for water entering from over the plastic sill plate. **Figure 16.**
2. If water is entering over the sill plate, remove the door panel and check that the plastic sheeting Butyl sealer is pressed firmly against the door frame. Also, check that no gaps are present between the sheet metal and the plastic.

3. Confirm that the door drain holes are draining properly and are not obstructed.

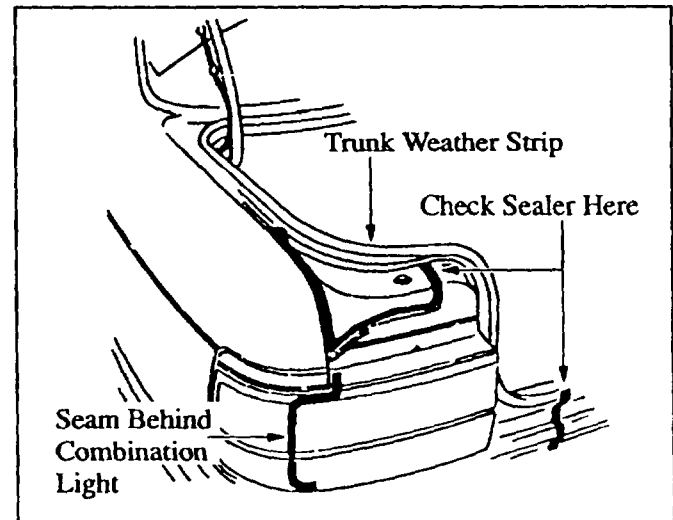
Figure 21: Inspecting Rear Trunk Area

2. If water is located behind the interior trunk end-panel trim or carpet, remove the trim panel. Direct a stream of water at the rear of the vehicle and pinpoint the location of the leak. Check the body seams for any pinholes or missing sealer. **Figure 21.**

- If the leak is from the combination lamp(s) area, confirm that the mounting studs/nuts are tight and the assemblies are not cracked. Check end panel-to-quarter panel seams for any pinholes or missing sealer. If the leak continues, remove the combination lamp(s) and gasket(s). Install a new gasket to the combination lamp(s). Figure 21.

3. If pinholes and/or missing sealer are found in step 2, add a non-hardening grey body seam sealer to fill in the empty spots and reinstall the trunk weatherstrip. Make sure the trunk weatherstrip is routed under the latch striker and press it firmly in place. Retest for water leaks.

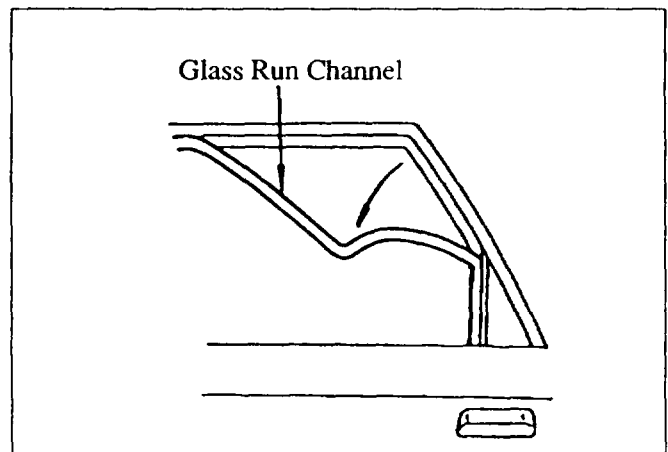
**Figure 15: Rear door**

Condition B: Wind noise at rear door area. (1988-'89 models only)

1. Lower window all the way.
2. Pull off the rear corner section of the glass run channel. **Figure 15.**

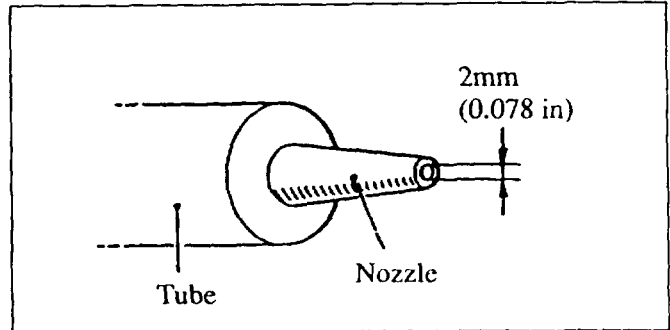
Figure 21: Tube of silicone sealer.

Condition C: Wind noise/fluttering noise at rear corner window area**1988-'91 2-Door Coupe**

1. Prepare a tube of silicone sealer as shown.
Figure 21.
