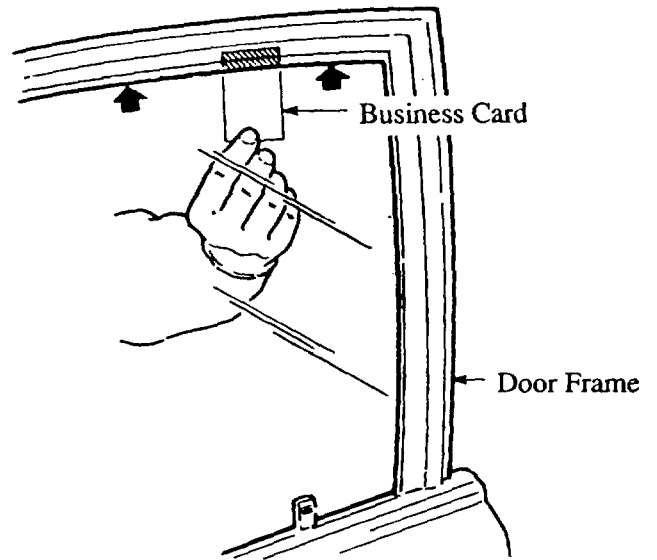
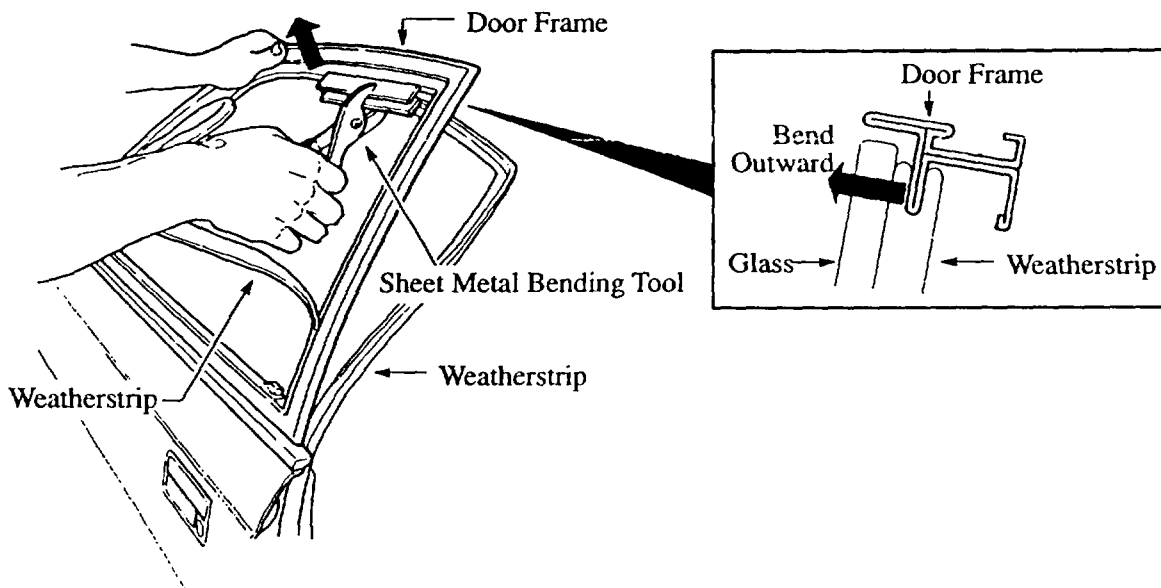
Condition D: Door Glass Drop

1. Use a business card as you would a feeler gauge to check for looseness (gaps) between the door glass and weatherstrip. The weatherstrip should press firmly against the glass around the entire door frame. Areas that do not form a tight seal between the glass and weatherstrip may allow the glass to drop thereby causing air leaks.
2. With the window in the down position, remove the following parts according to Workshop Manual procedures section S:
 - a) Black Plastic Inner Sail Garnish
 - b) Window Frame Weatherstrip
3. Remove the weatherstrip to access the glass run channel frame.
4. Carefully bend the weatherstrip frame slightly outward (1/16") to increase the pressure of the weatherstrip against the glass. Use a sheet metal bending tool (Snap-on P/N VP8R or equivalent).

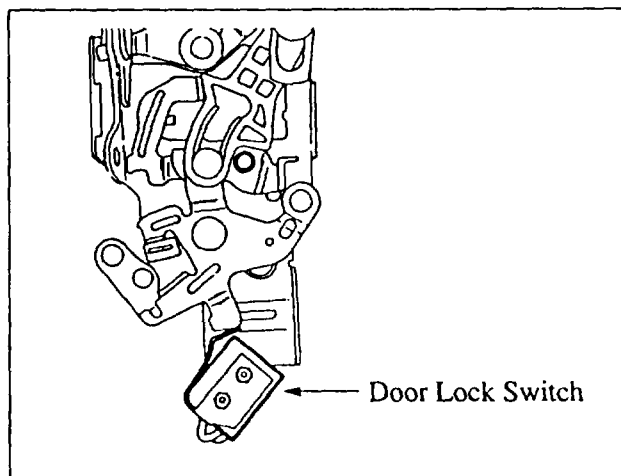
Figure 1: Power Door Lock Switch
(Driver's Door)

A driver's side door lock that does not lock or unlock the remaining doors may have a damaged circuit in the door lock switch.

1. Inspect switch. See Section 14 or S of the Workshop Manual.
2. If necessary, replace the driver's door lock switch. See Workshop Manual for replacement procedures. **Figure 1.**

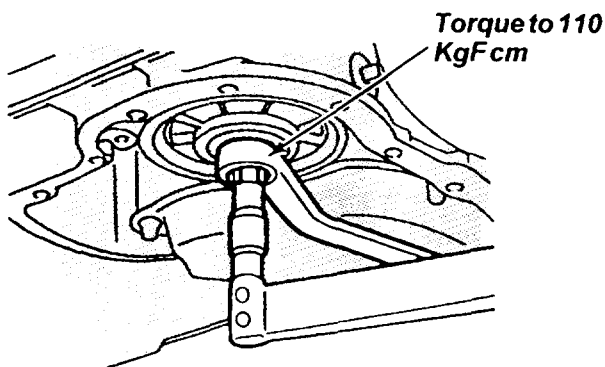
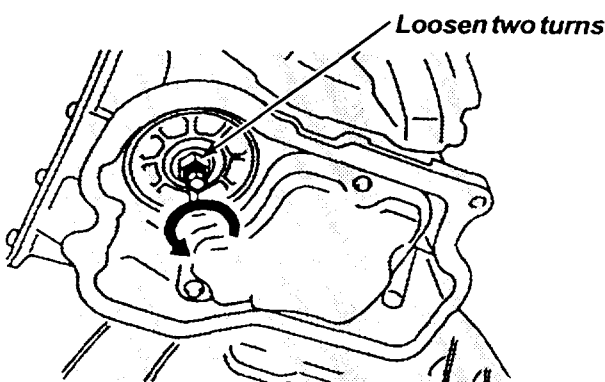
A harsh shift from first to second and second to third may be the result of a tight 2-4 brake band adjustment. To confirm the condition, test drive two equally equipped vehicles and compare shift quality. If you verify the condition, adjust the band according to the Workshop Manual procedure on page K1-111, using the following new specifications for steps 10 and 11:

Step 10 - Torque piston stem to **110 KgF cm**.

Step 11 - Loosen piston stem **two turns**.

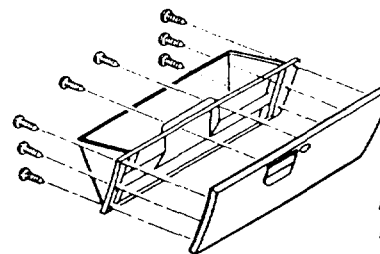
Hinge Screws (2 total)

A glovebox door and hinge that rattles or squeaks may be a result of loose screws. To eliminate this condition, make sure the two hinge screws and the eight inner glove box lid screws are adequately tight.

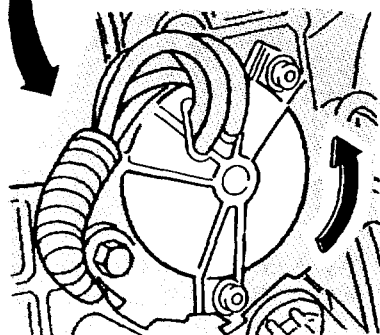
Rotate one notch

An open electrical contact in the change motor position plate may prevent shifts into or out of four wheel drive intermittently. To correct this condition, rotate the plate cover one notch counterclockwise after loosening the three cover screws.

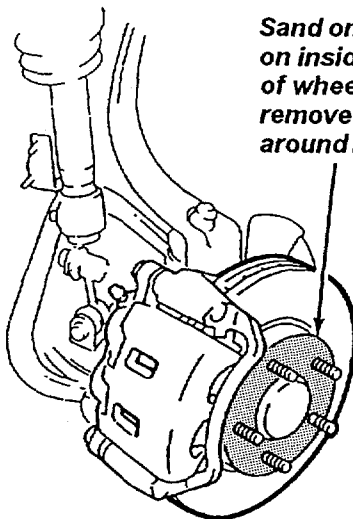
Sand on this surface and on inside mounting surface of wheel. You don't need to remove brake rotor (sand around bolts).

You probably don't need to replace any parts if a customer complains the vehicle's front wheels make a clicking sound. Often, several clicks can be heard from the outside wheel during a slow turn.

We featured this concern in the June issue of *Mazda Tips* and the fix still applies: remove the wheel, then use coarse sandpaper to clean the disc plate's contact area and the wheel mounting surface (see illustration). Carefully remove the abrasive dust produced from sanding and re-install the wheel. Tighten lug nuts to a maximum torque of 94 ft. lbs.

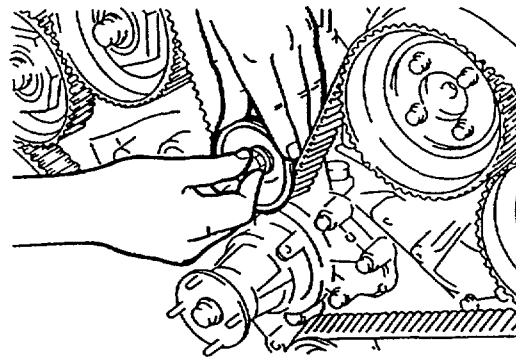
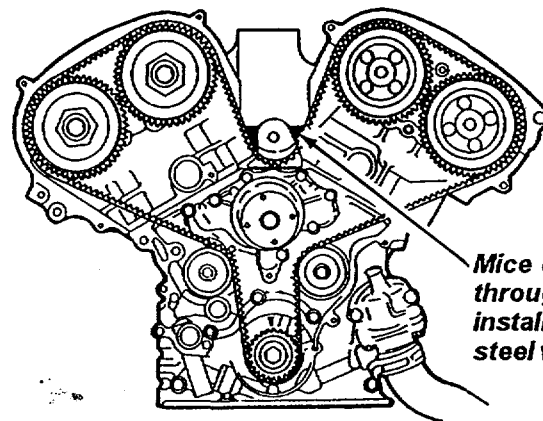
Remove No. 2 Idler Pulley to see gap.

Mice may cause the belt to jump teeth. In cold climates especially, they can crawl through a gap between the two cylinder heads and possibly build a nest on the belt. When the engine starts up, this interference may force the belt off track.

If you discover this condition, you can prevent it by cleaning and re-setting the belt, then putting stainless steel wool in the gap. You must remove the No. 2 Idler Pulley to get to the gap (see WSM pages B12 to B15). Don't use plain steel wool because it will rust.

Next, clean the engine surfaces around the wool and apply high-temperature silicone around it. This will form a seal to the surface and reinforce the blockage.

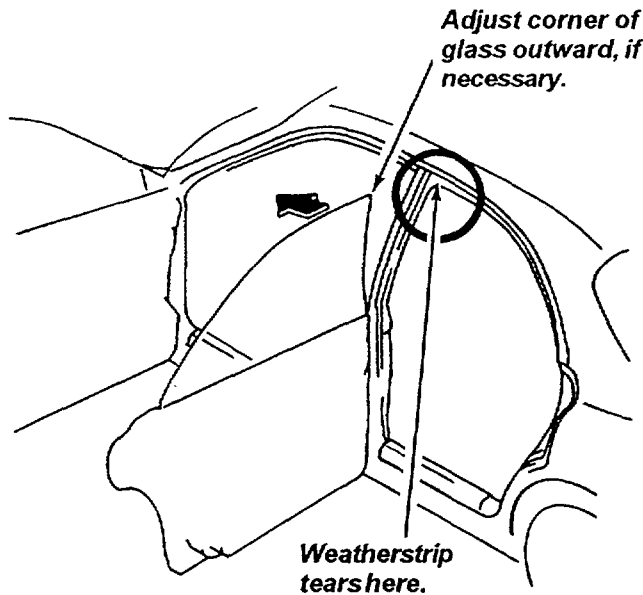
A torn weatherstrip at the rear door's upper front corner may cause wind or water leaks. In

time, the weatherstrip could tear if a slightly misaligned door glass digs into it when the door is closed.

If the weatherstrip is torn, install a new one, but ensure the door glass is properly adjusted. If the glass is set too far inward, adjust the corner slightly outward, according to the Workshop Manual procedure (page S-22). Be careful not to adjust it too far outward or you'll create another wind or water leak.

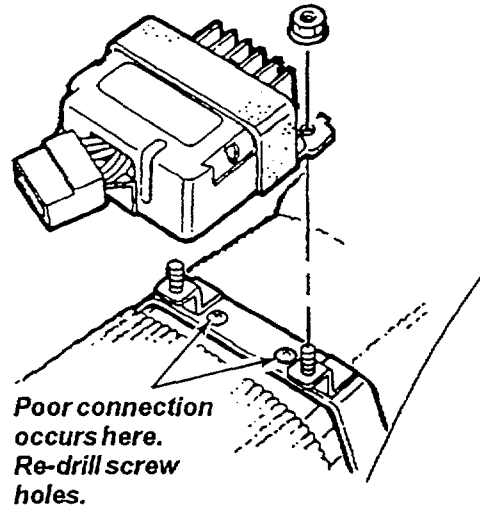
The poor connection results from stripped screw holes on the bracket. Redrill the screw holes and use either larger machine screws or rivets. You might also consider installing a separate ground wire to the vehicle body.

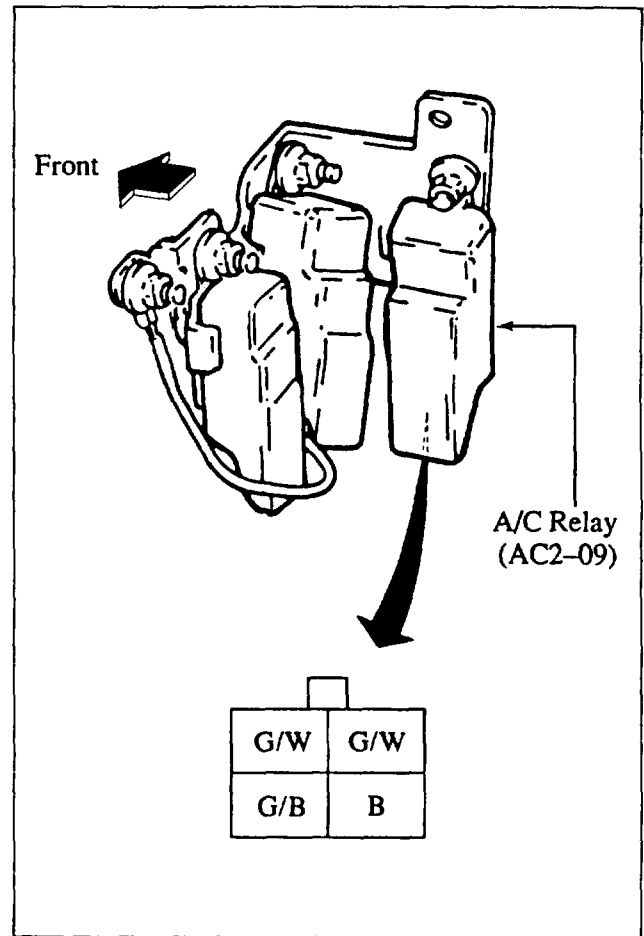
Since the E.C.U. has not been modified, the A/C relay (AC2-09) should be replaced with a new, resistance-type relay. Used in the 1990 626/MX-6 models, the resistance-type relay prevents the surge current from flowing into the control unit.

The A/C relay (AC2-09) is located below the right headlamp. There are three relays in one place. Locate the A/C relay by referring to the wire colors illustrated.

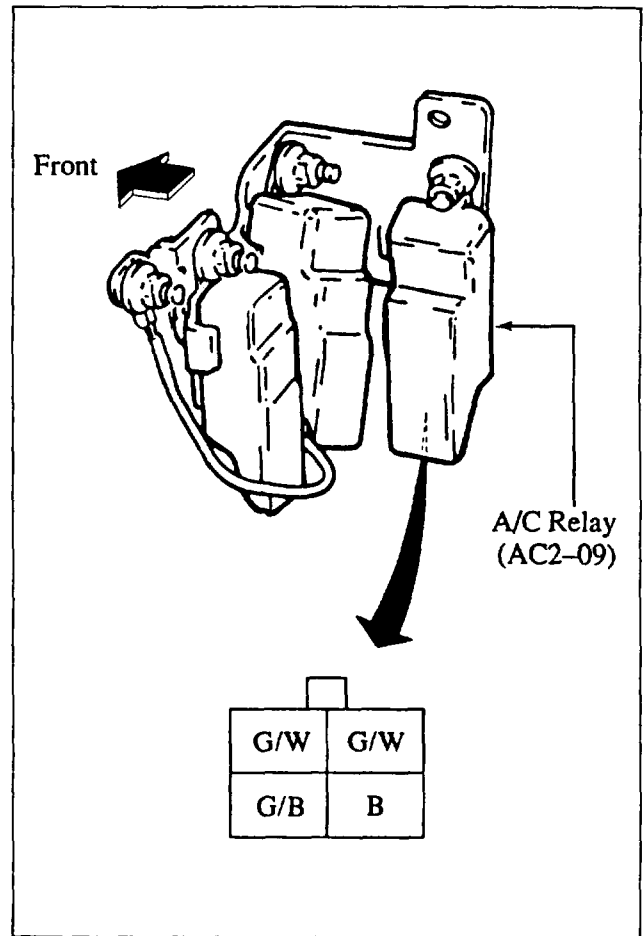
Since the E.C.U. has not been modified, the A/C relay (AC2-09) should be replaced with a new, resistance-type relay. Used in the 1990 626/MX-6 models, the resistance-type relay prevents the surge current from flowing into the control unit.

The A/C relay (AC2-09) is located below the right headlamp. There are three relays in one place. Locate the A/C relay by referring to the wire colors illustrated.

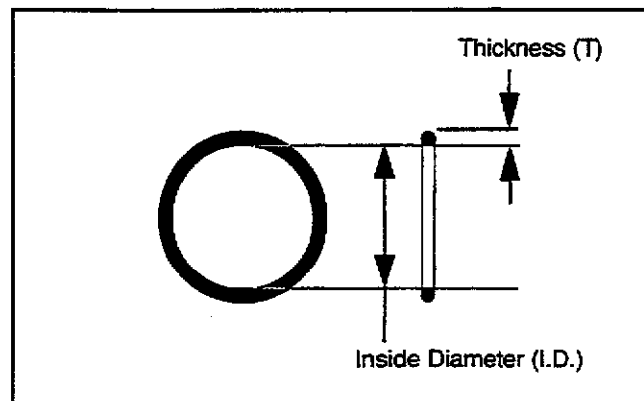
The illustration to the right indicates where the o-ring must be measured to determine diameter and thickness. Use this information and the chart above to identify the proper part if the o-rings are accidentally mixed.

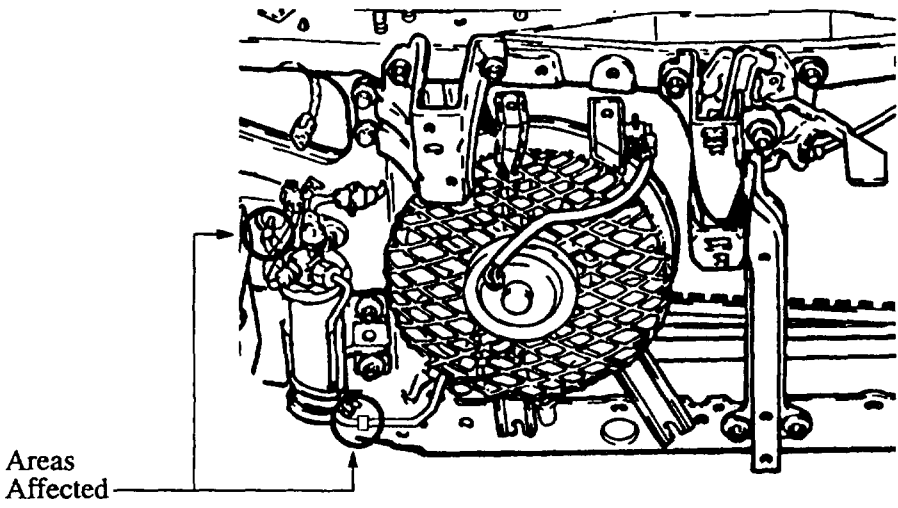
It has been found that the inlet or outlet pipe of the receiver/drier tank may develop a pinhole at the area shown below where the pipes are held by small steel clips. This may result in a refrigerant leak.

Galvanic corrosion occurs between the aluminum pipe and the steel clip. This condition is more likely to develop in geographic areas that use large amounts of salt on the roads and highways.

- If a refrigerant leak is suspected, inspect the pipes of the receiver/drier tank.
- The inlet/outlet pipes are available as a service part. Refer to the parts information in this bulletin.
- In order to prevent galvanic corrosion from recurrence, place vinyl tape (insulator tape) between the steel clip and the aluminum pipe.

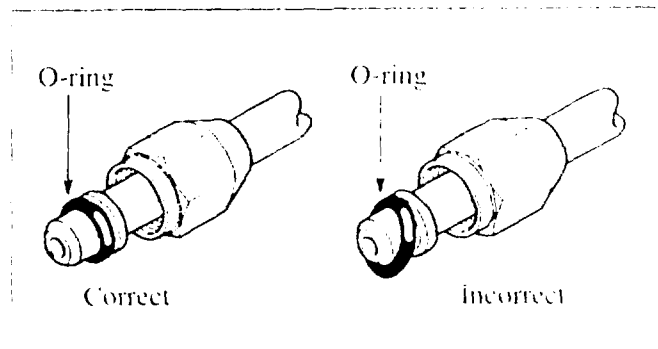
Figure 1: O-Ring Placement

1. Before installing the O-ring, inspect the pipe/hose for any damage.
2. Verify the O-ring is clean and free from defects. Place O-ring on pipe. Be sure it is seated properly (figure 1).

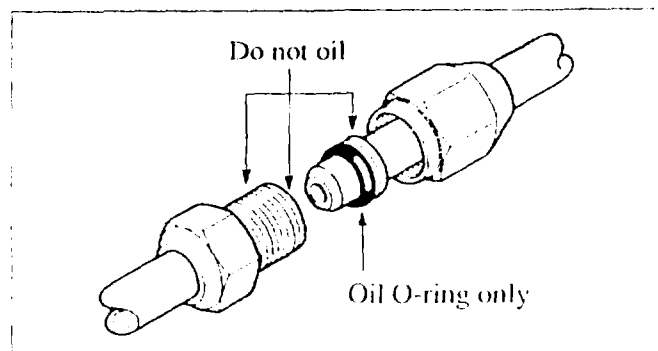
Figure 2: Oil Locations

3. Lightly apply oil to the O-ring with refrigerant oil. Do not oil the threads or connecting hose seat (figure 2).

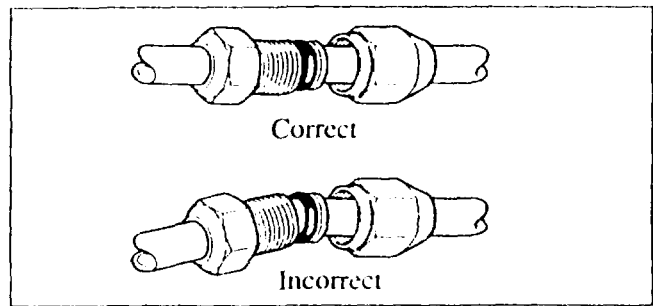
Figure 3: Fitting Alignment

4. Align both fittings before threading on the nut (figure 3).

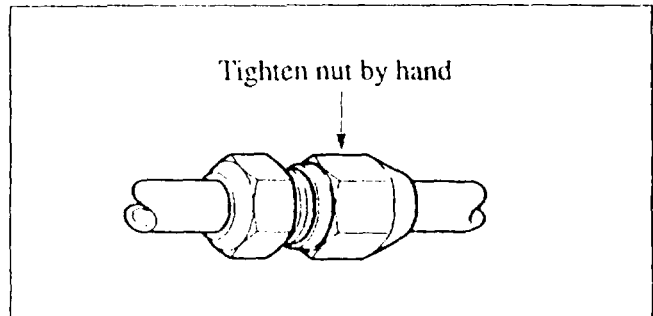
Figure 4: Tightening of Fitting

5. After threading on the nut, tighten it by hand as much as possible (figure 4).

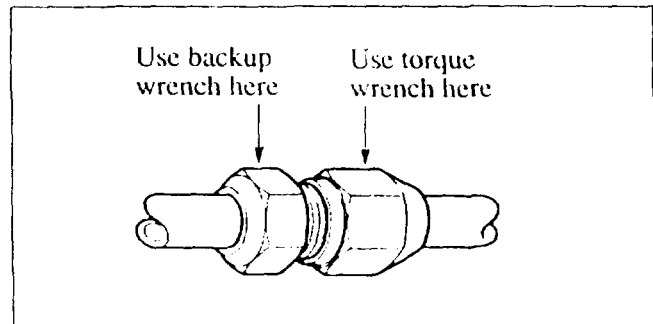
Figure 5: Final Tightening of Fitting

6. Torque the nut to the proper specification, using a backup wrench to prevent damage (figure 5).

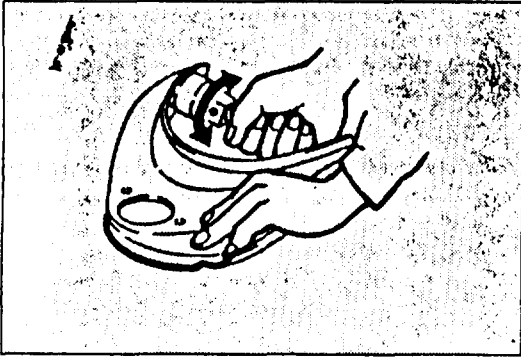
1BU0RX-024

If the upper arm shaft cannot be turned smoothly, replace the upper arm and/or threaded bushings.

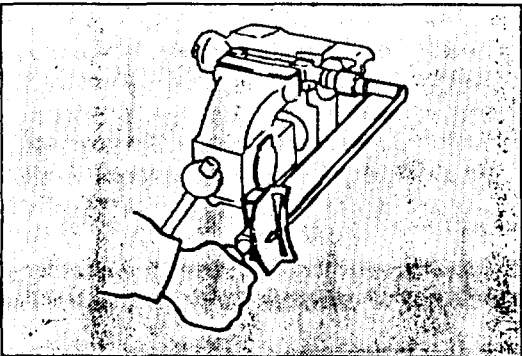
1BU0RX-027

If the specified tightening torque cannot be obtained, replace the upper arm and/or threaded bushings.

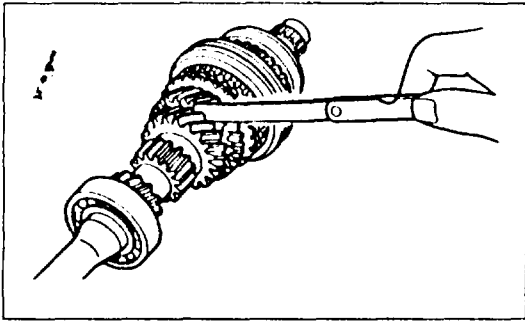
03U0J1-039

Maximum: 0.26mm (0.010 in)

2. If the clearance exceeds the maximum, check the contact surfaces of the 3rd gear, 2nd gear and clutch hub (3rd/4th). Replace worn or damaged parts.

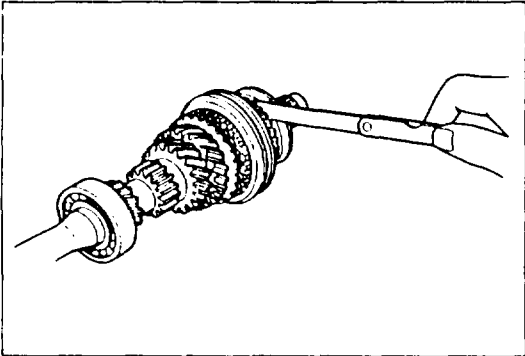
03U0J1-040

Maximum: 0.66mm (0.026 in)

2. If the clearance exceeds the maximum, check the contact surfaces of the 4th gear, ball bearing, and clutch hub (3rd/4th). Replace worn or damaged parts.

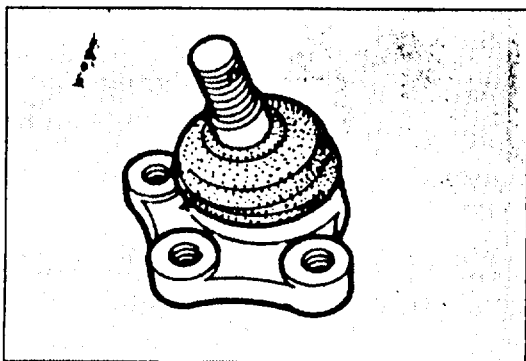
1BU0RX-026

1. Cracking, damage, and bending of upper arm and upper arm shaft.
2. Damage and poor operation of upper arm ball joint.

Check for the following and repair or replace parts as necessary.

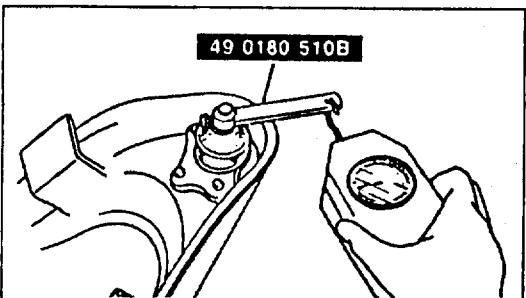
1BU0RX-027

3. Upper arm ball joint preload.

Pull scale reading: 20—34 N (2.0—3.5 kg, 4.4—7.7 lb)
(While ball stud is rotating)

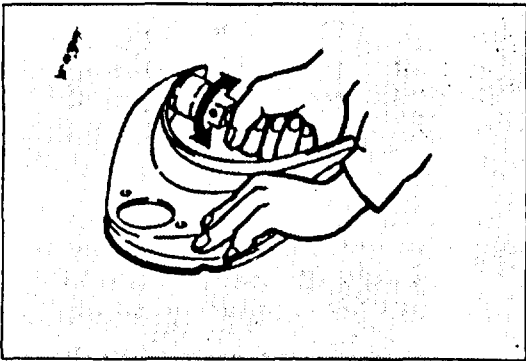
1BU0RX-024

If the upper arm shaft cannot be turned smoothly, replace the upper arm and/or threaded bushings.

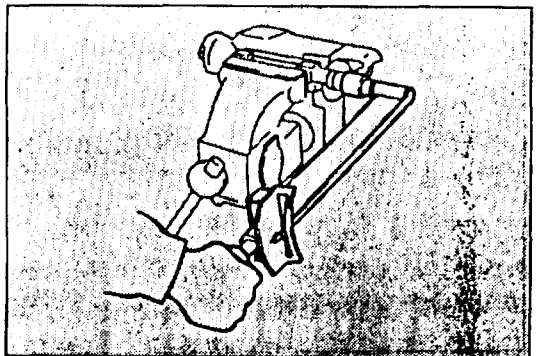
1BU0RX-027

If the specified tightening torque cannot be obtained, replace the upper arm and/or threaded bushings.
